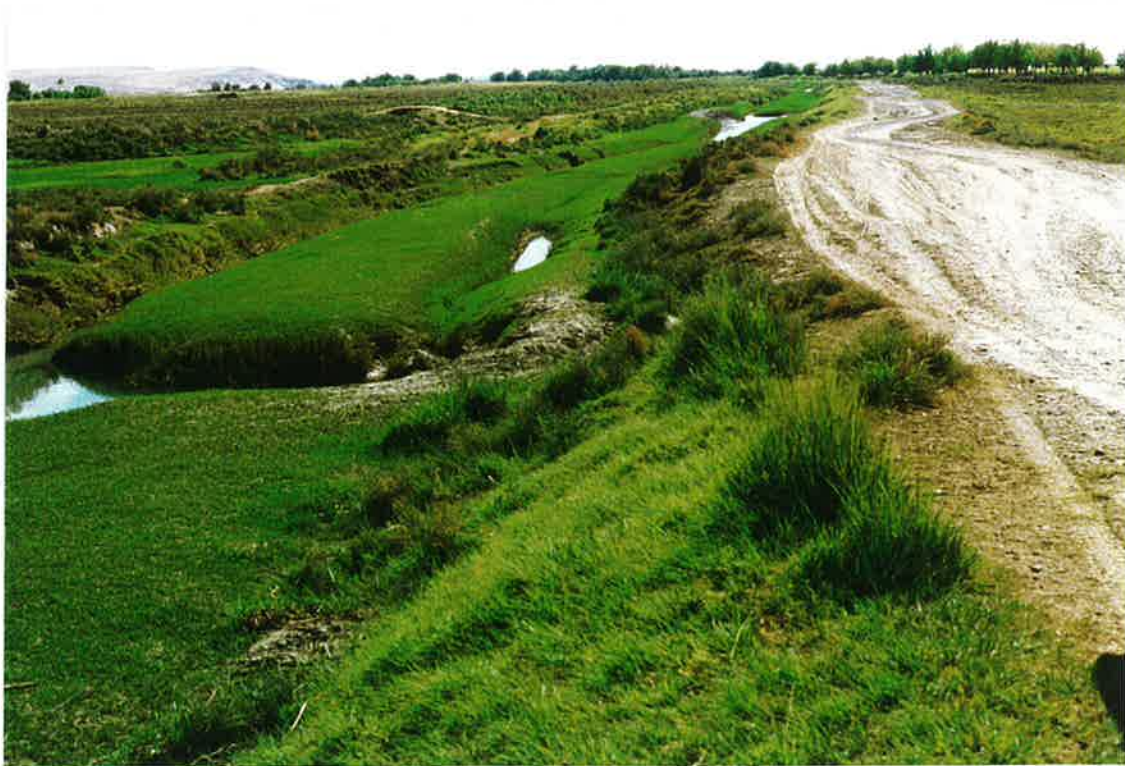
45. Silted lower Shamalan Canal in Zarist area. 17 Oct 97

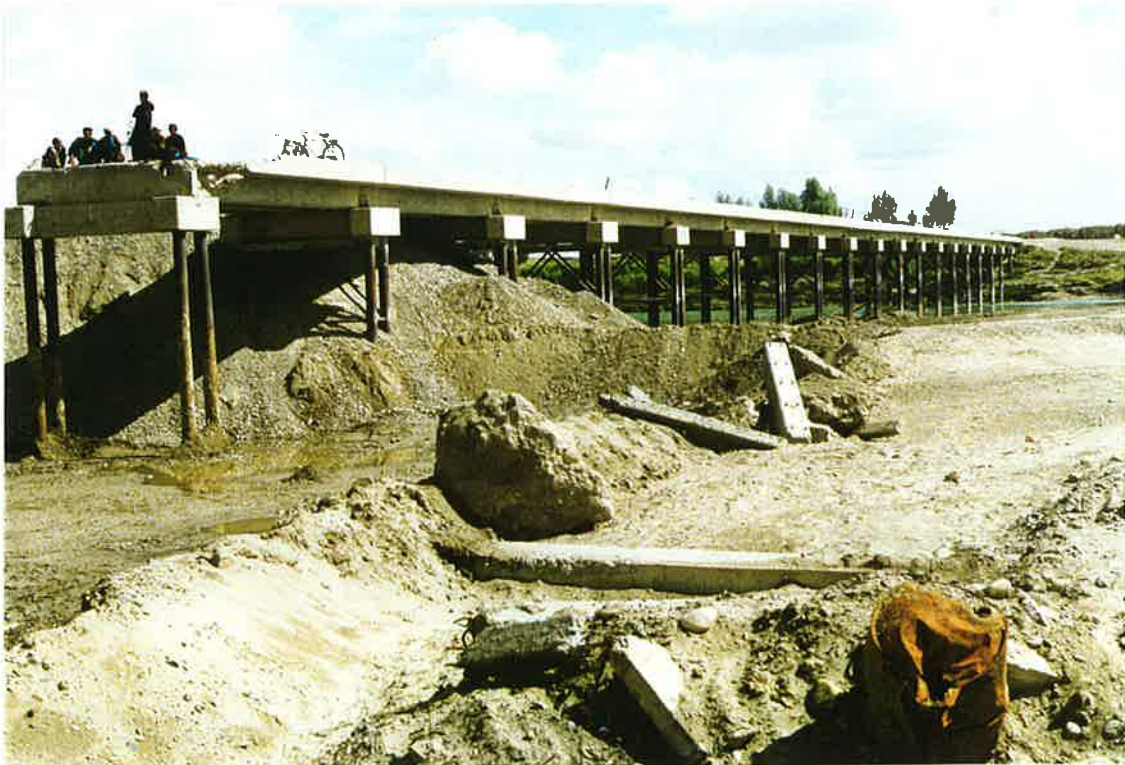
46. Darwishan Bridge looking east. Original structure intact.
17 Oct 97

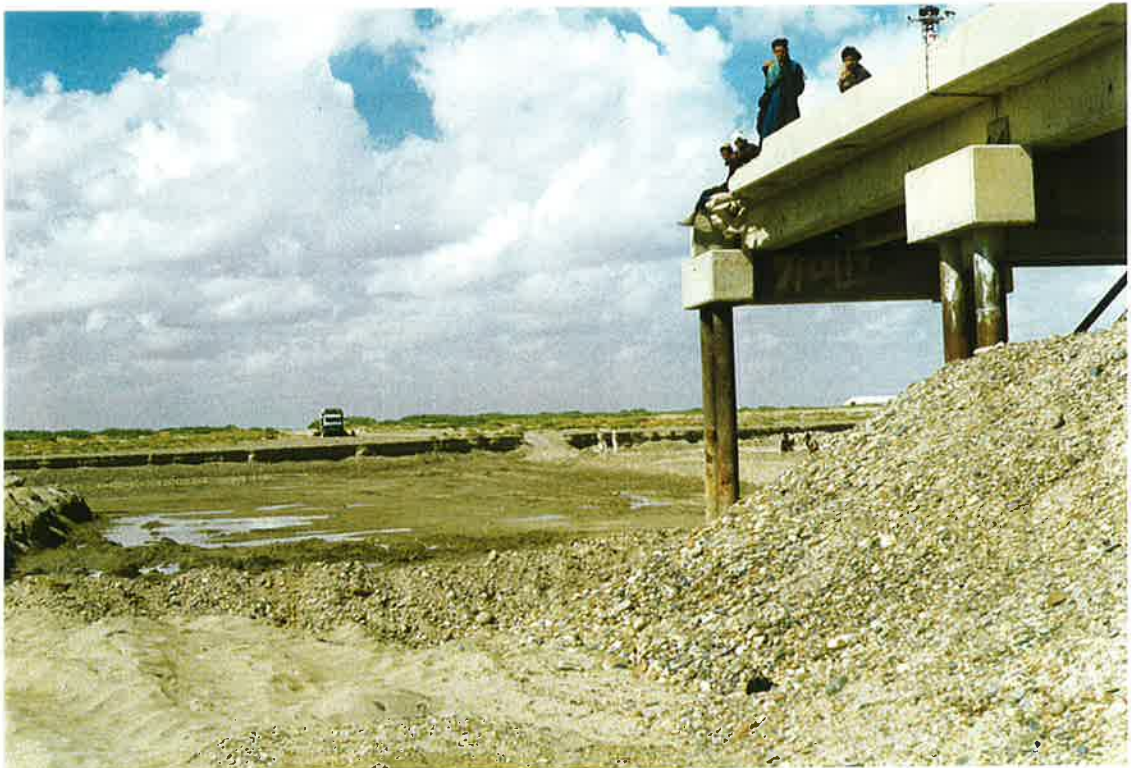
47. Washed out Darwishan Bridge approach looking west. Approach is excavated and ready for gabion fill. 17 Oct 97

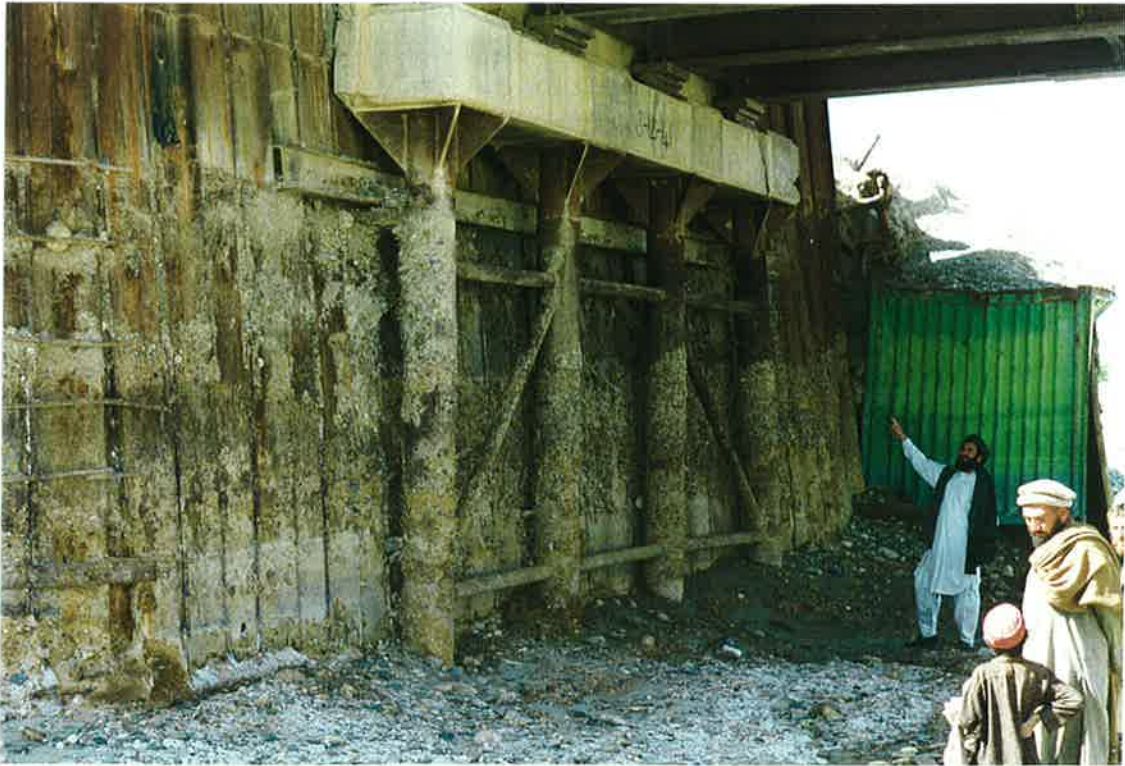
49. West end of Lashkar Gah bridge with cracked beam. Note old container being used as bridge protection from flood flows. 21 March 97

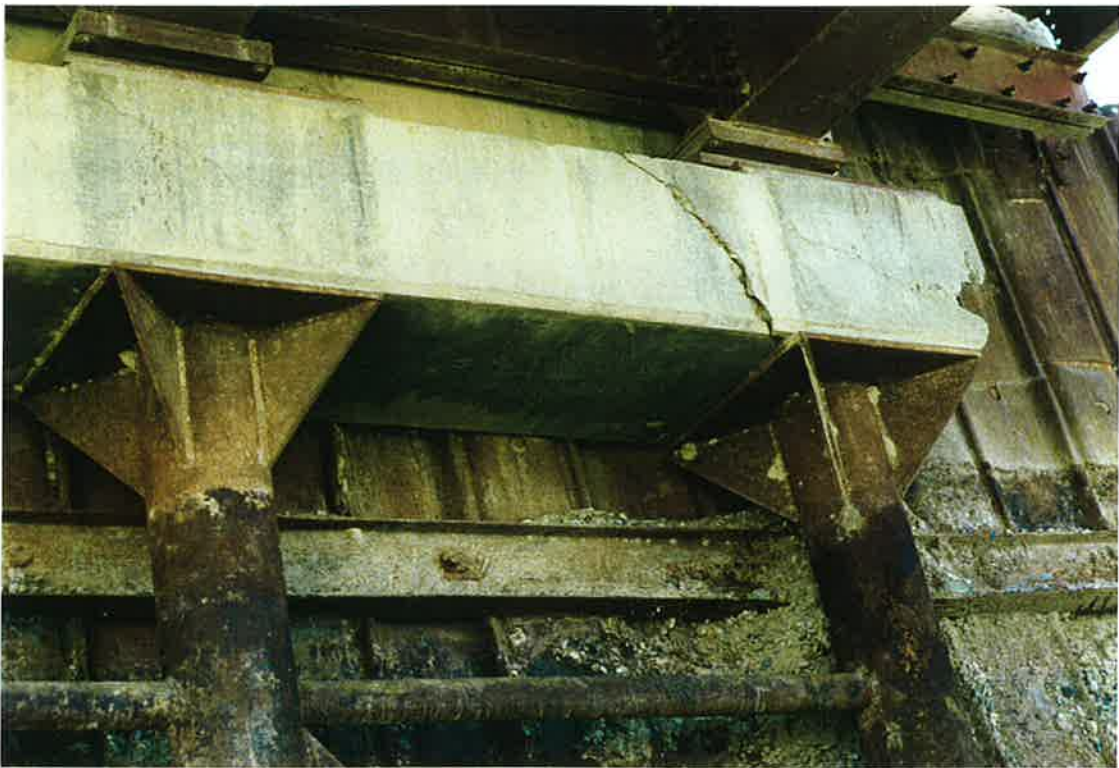
50. Close up of cracked bridge beam. 21 March 97

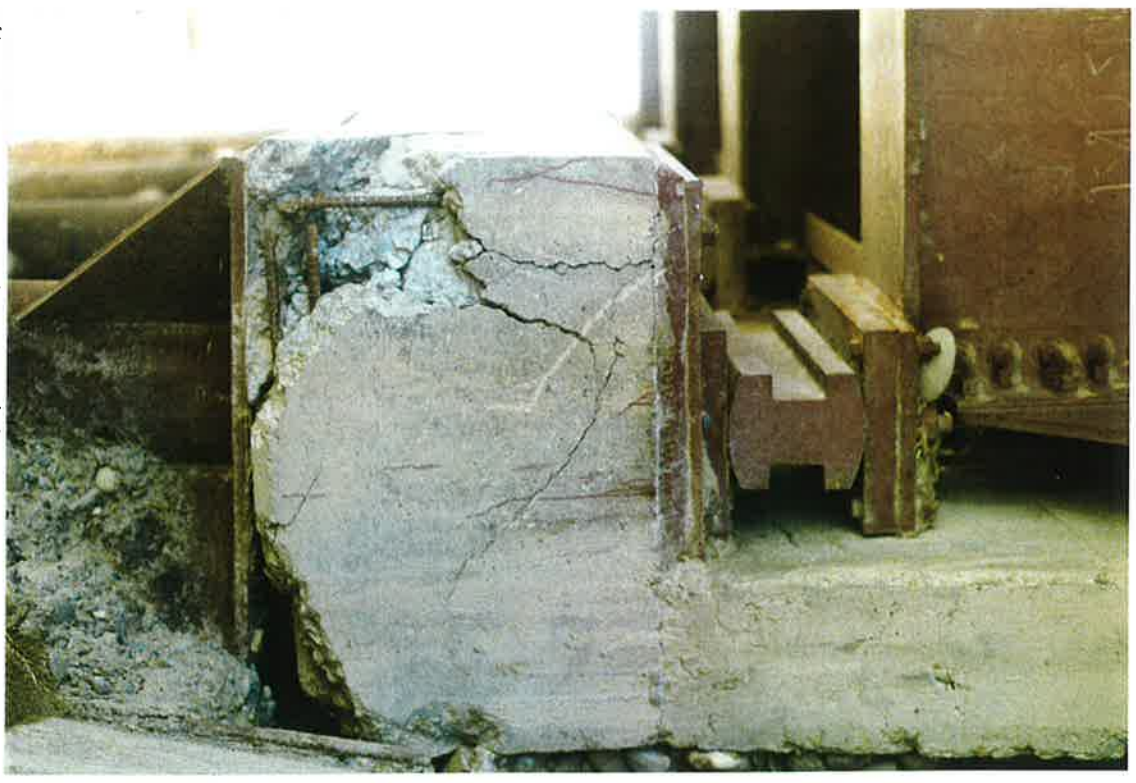
52. End view of damaged bridge beam of Loskkrabak
bridge. 21 March 97

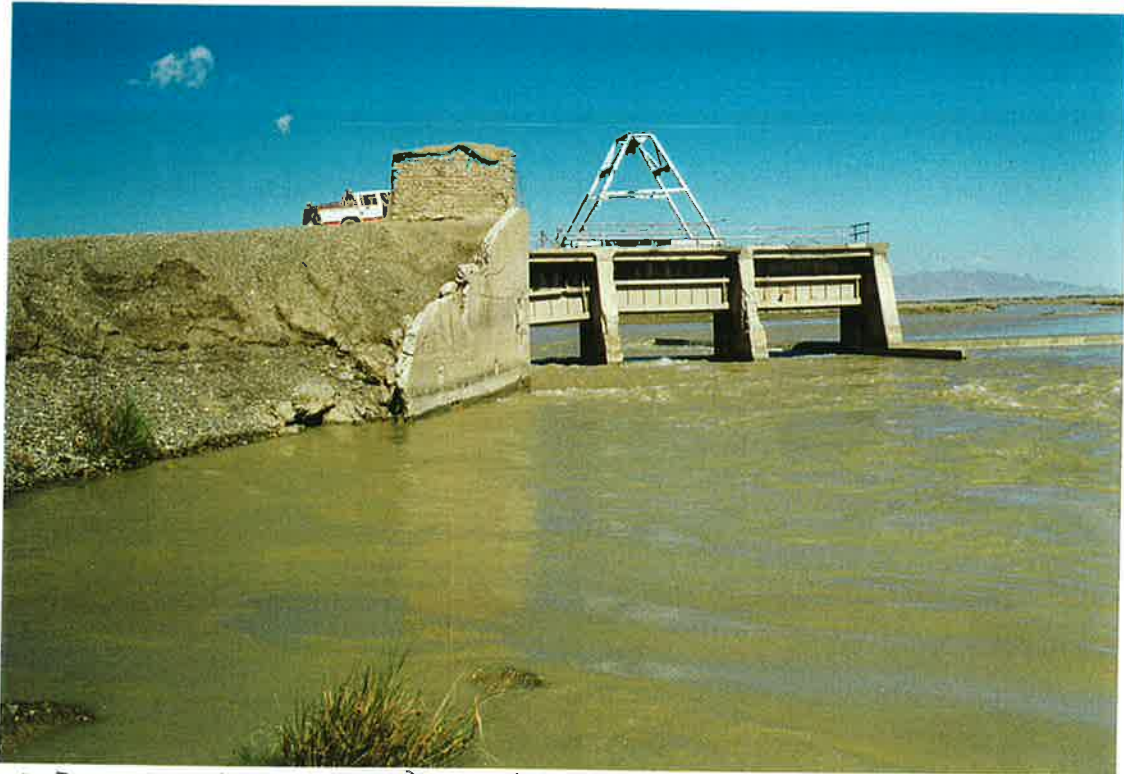
53. Diversion structure of Boghra Canal intake off the Helmand River. Note wash out on left, 20 March 97

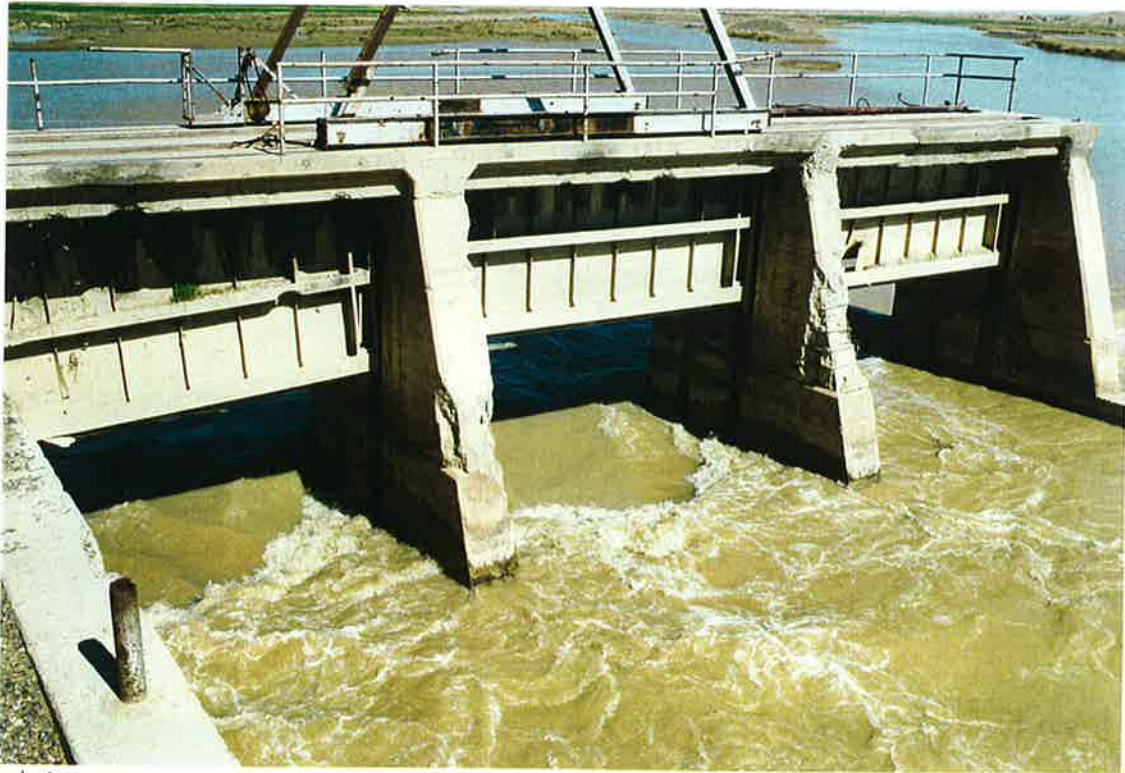
54. Diversion structure of Boghra canal intake on Helmand River. Note damaged concrete. Gates functioning. 20 March 97

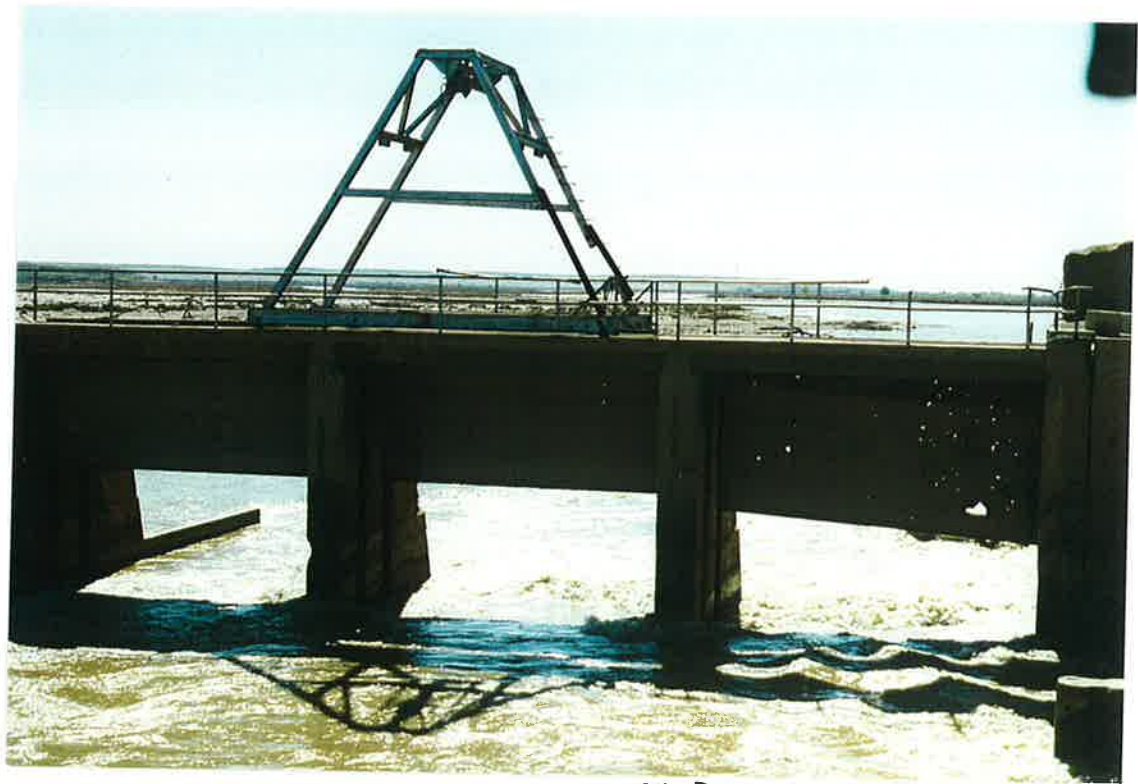
55. Diversion structure of Boghra canal intake on Helmand River from up-stream. Note damaged but functioning gate on right, 20 March 97

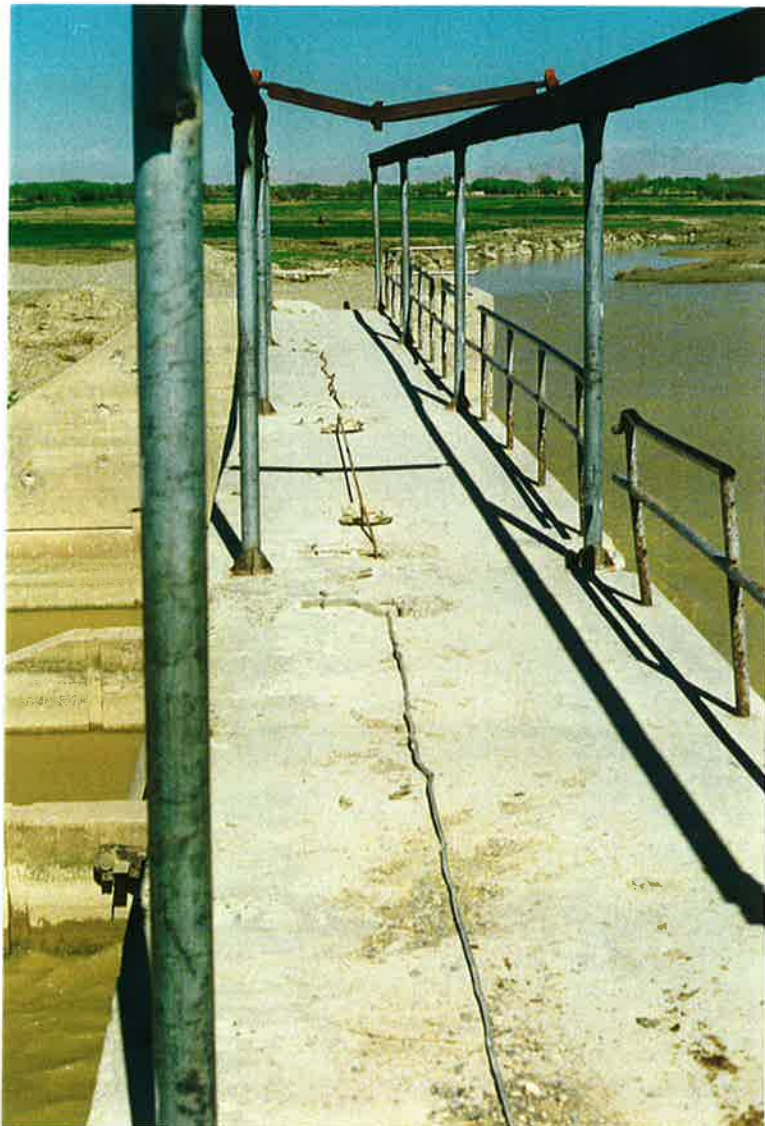
58. Baghra Canal intake structure on Helmand River with missing gates lift mechanisms. Note failed over-head lift beam. 20 March 97

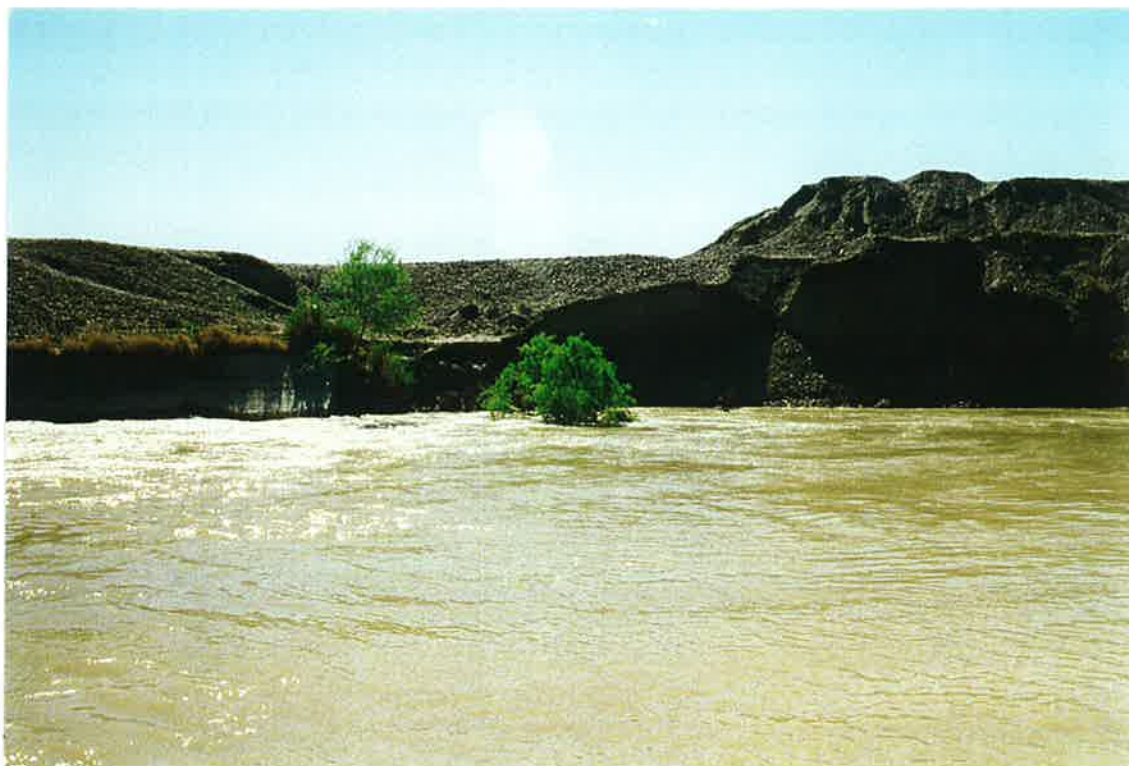
61. Washed out left wing of Boghra Canal intake structure. 20 March 97

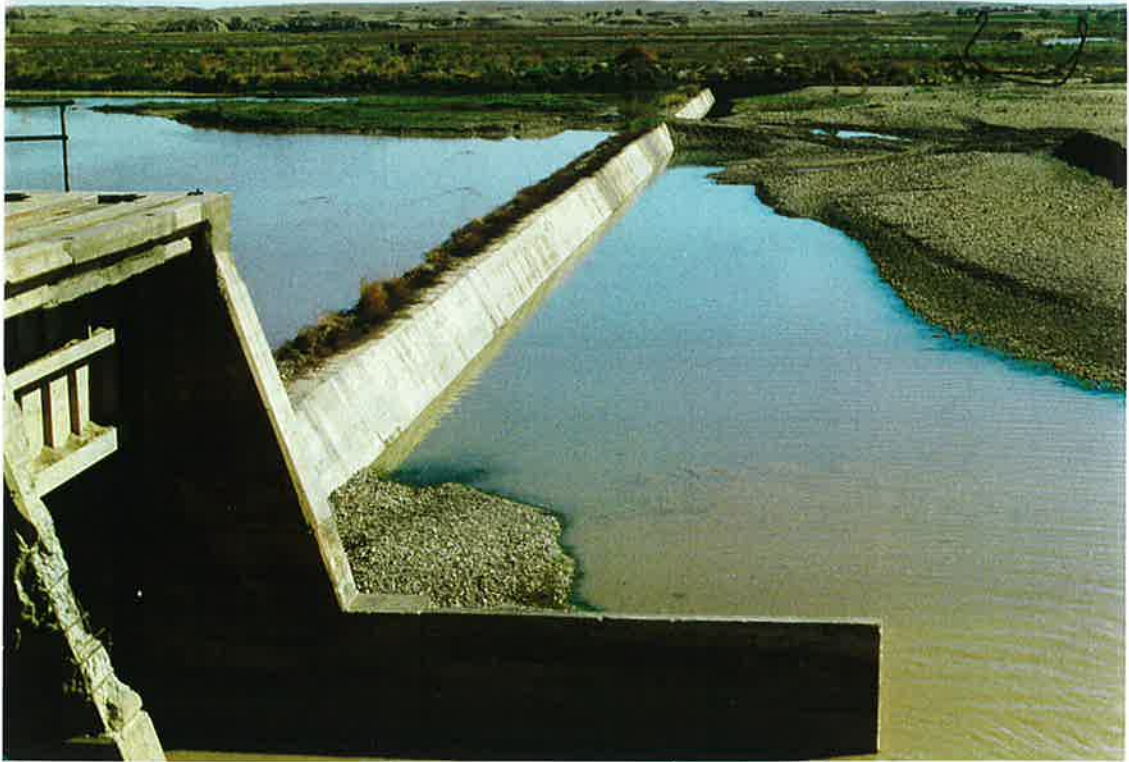
63. Old failed MKA river diversion dike (ca. 1947) on Helmand River
From Boghra canal diversion structure at intake. Dike in upper right corner.
20 Oct 97

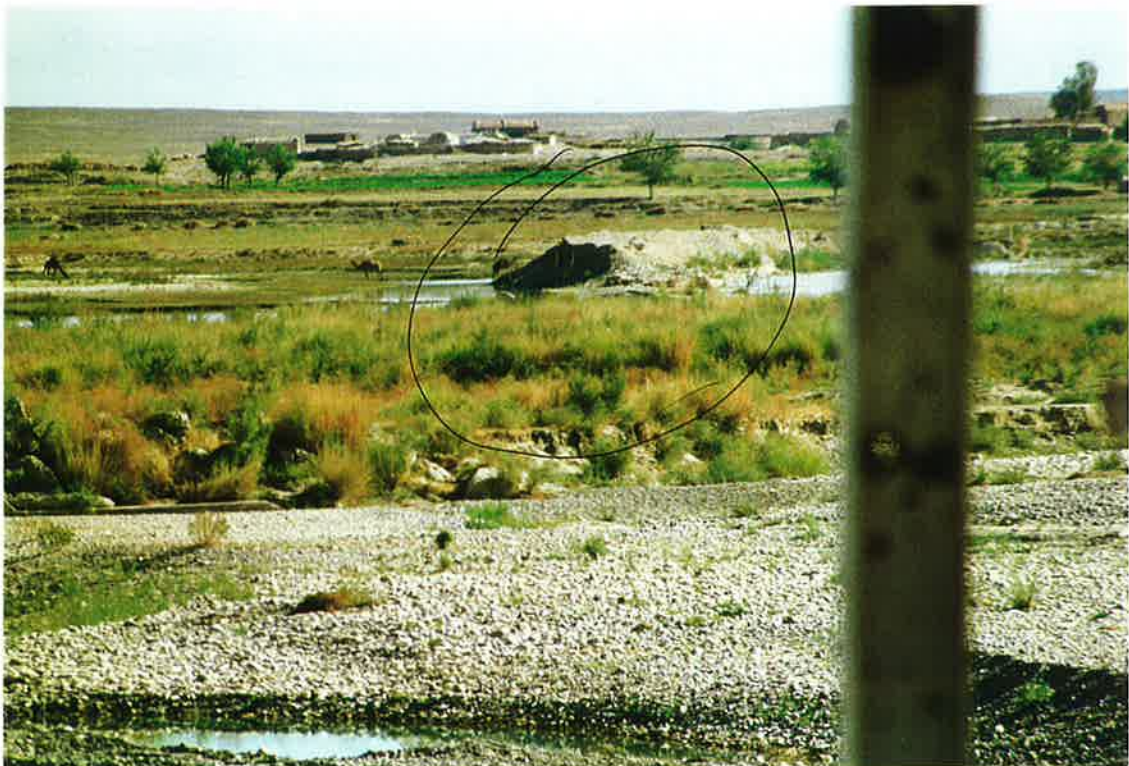
64. Close up of old failed MKA river diversion dike on Helmand River.
20 Oct 97

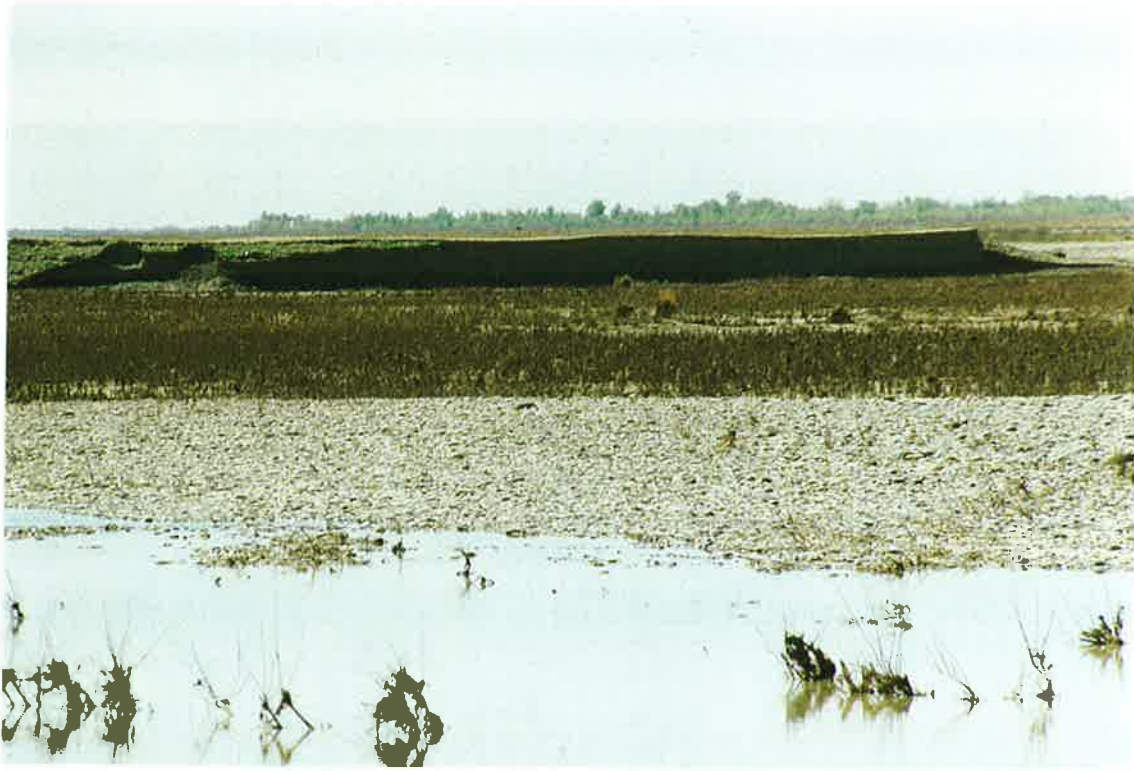
65. Old Failed MKA river diversion dike on Helmand River from north,
20 March 97

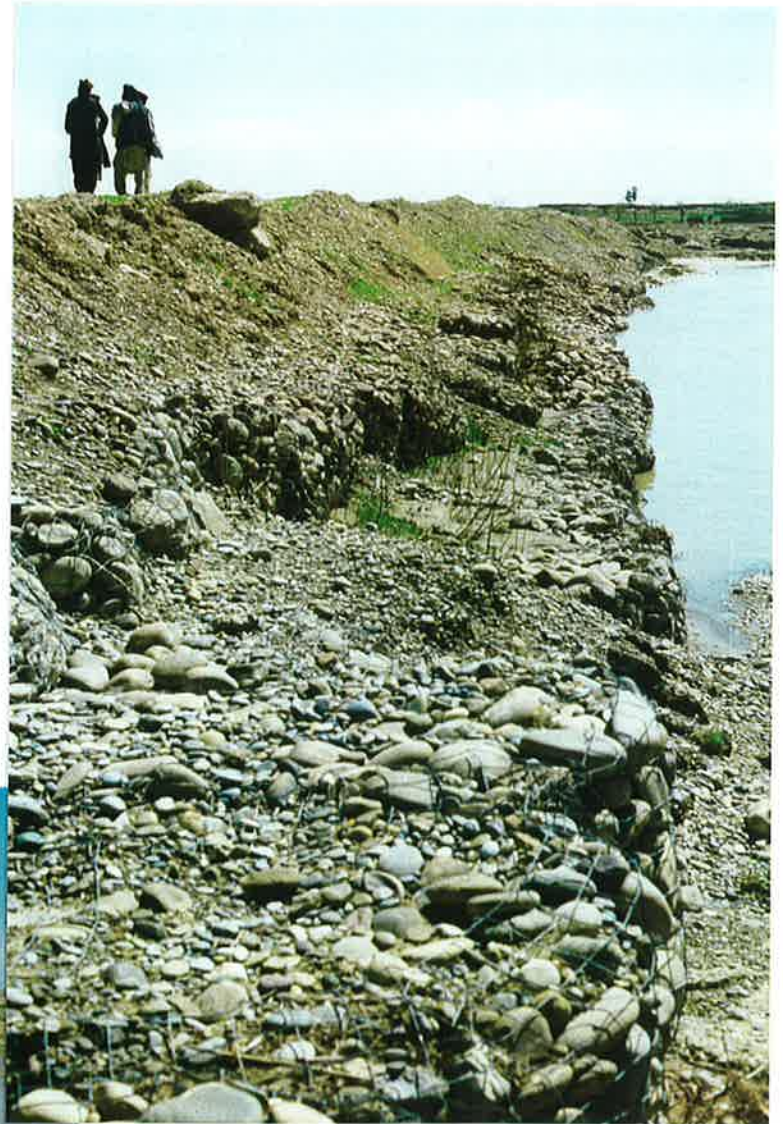
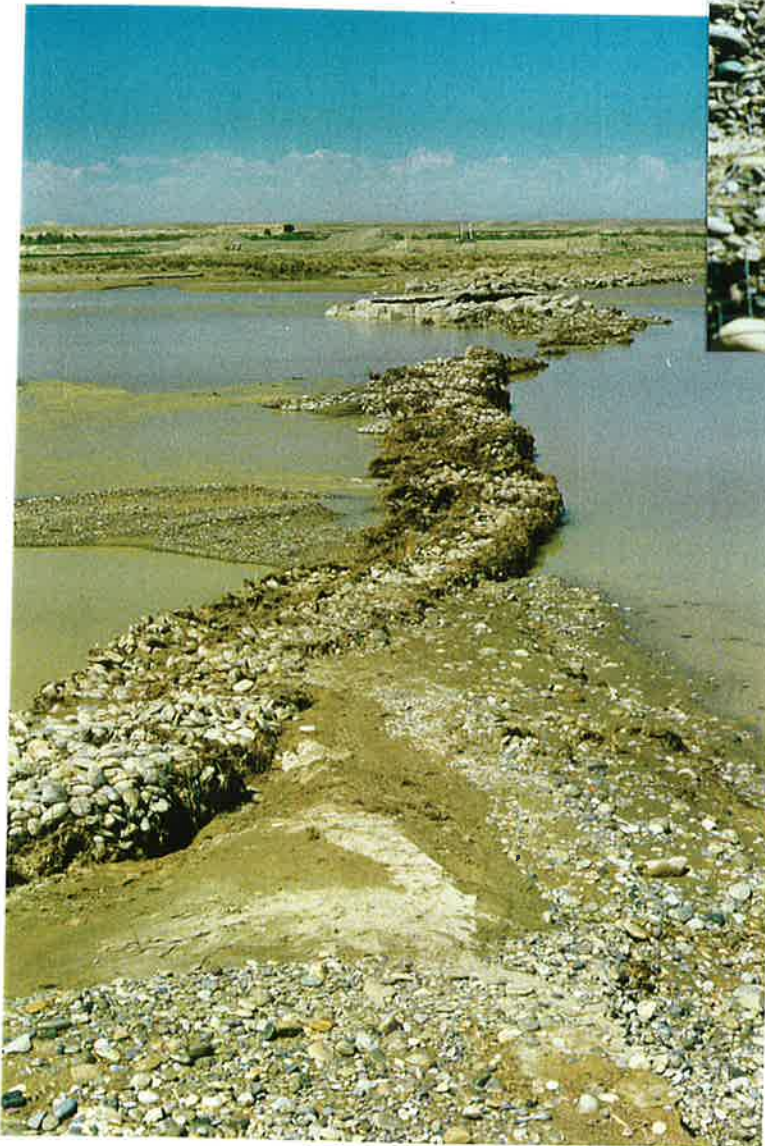
67. Close up of old failed
MKA river diversion dike,
down-stream (south) side with
recent repairs.
20 March 97

68. Close up of failed recent repairs to
old failed MKA river diversion dike
on Helmand River from old dike
looking west.

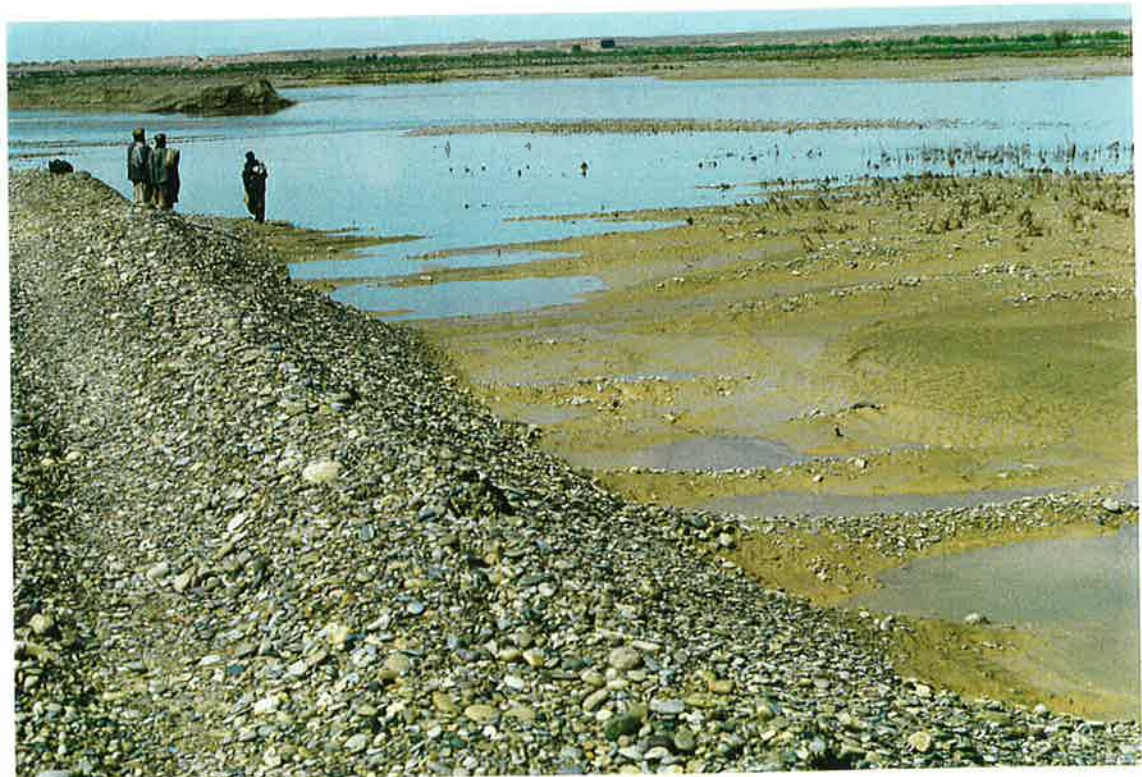
72, Failed recent attempt at river diversion dike funded by Farmers, located between the 2 MKA diversion dikes. 20 March 97

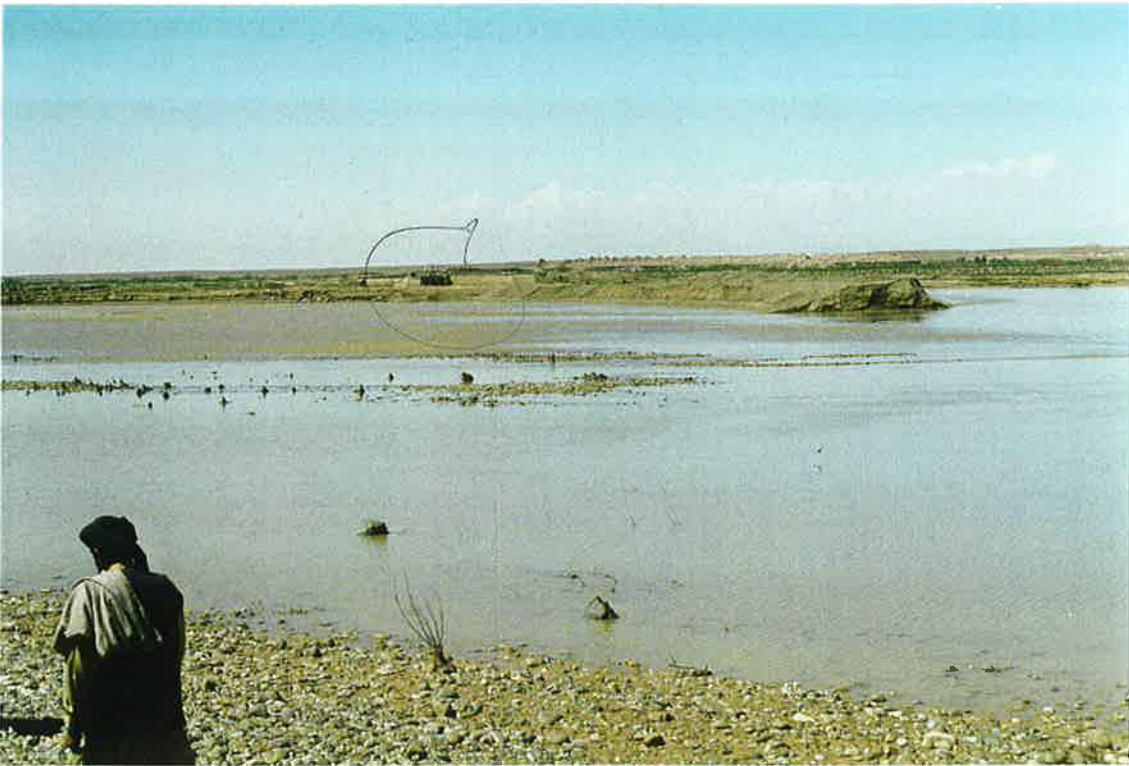
73. Recent failed river diversion dike funded by farmers from the east, The Boghra canal intake structure is left of center. 20 March 97

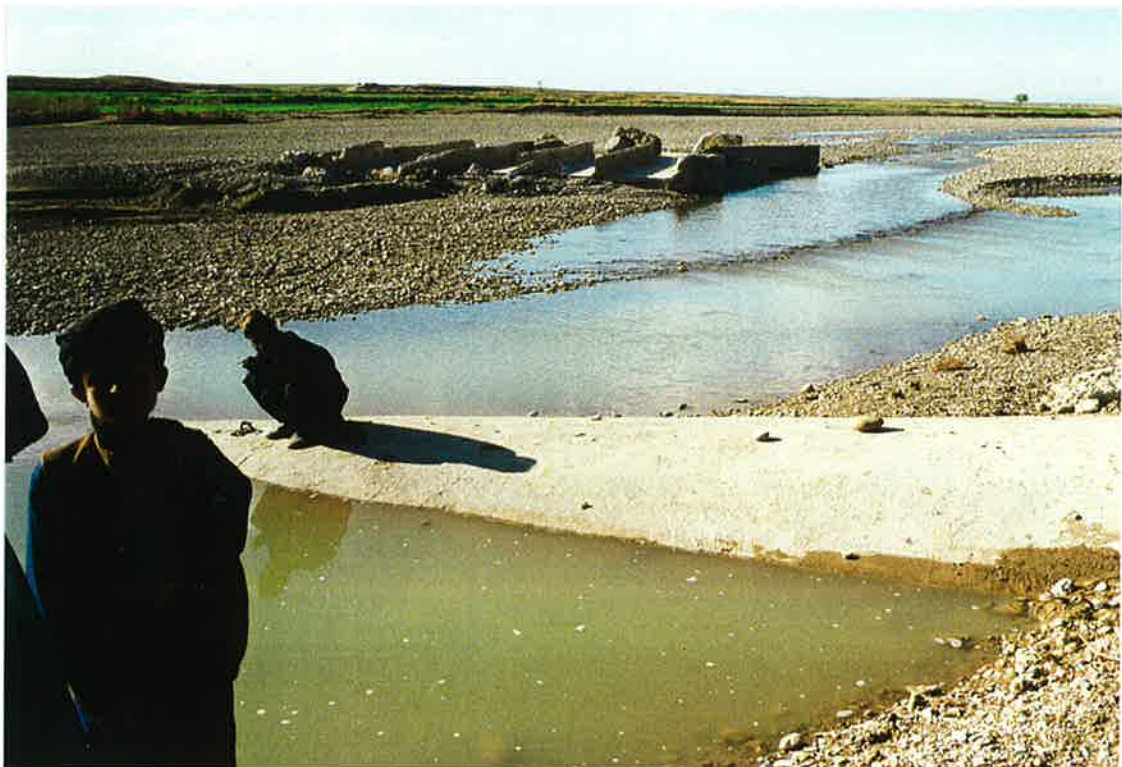
78. Exposed siphon and washed out channeling at Ab Pashak wash.
In October the siphon had been re-covered by gravel/silt.
20 March 97

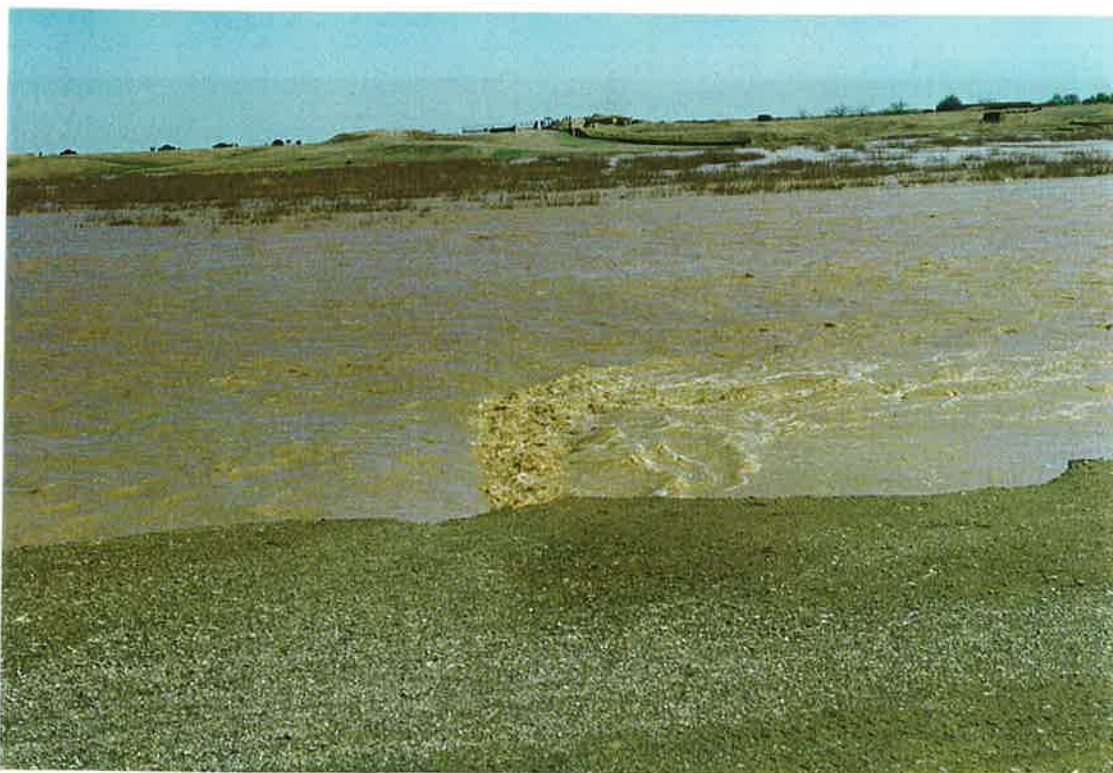
79. Lay Munda siphon being eroded out by spring flood.
18 March 97

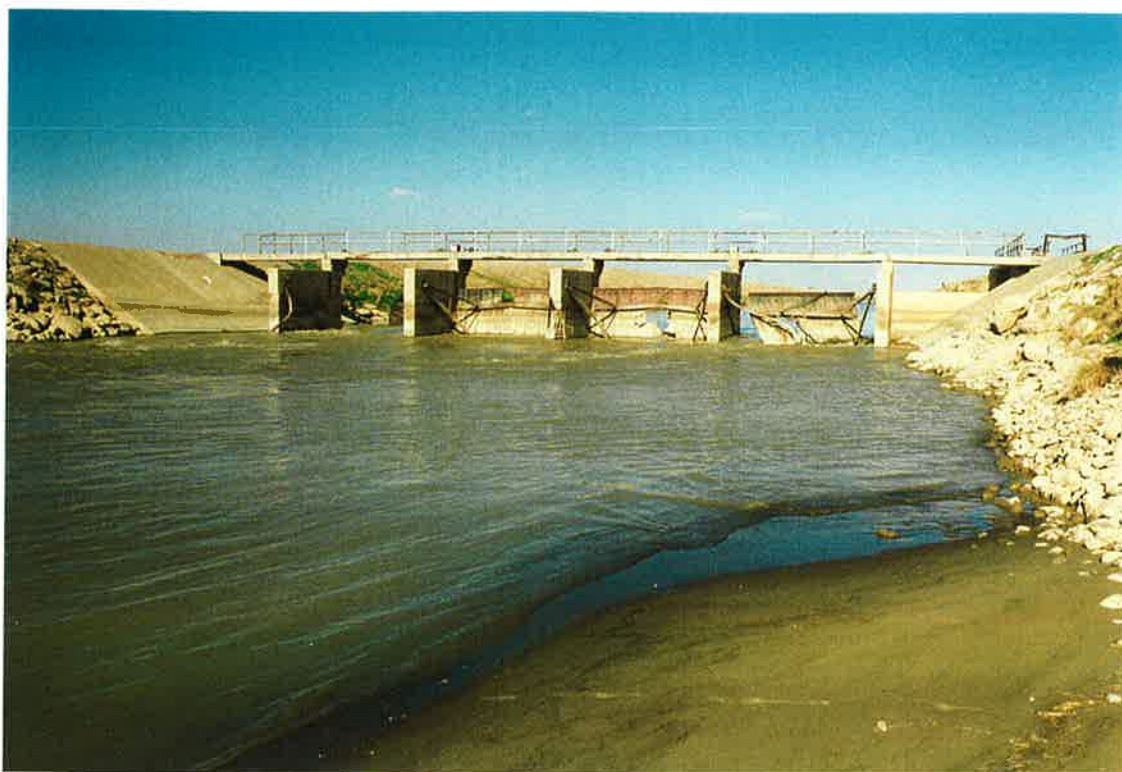
80. Control structure on Boghra canal at wasteway north of Shamalan diversion. All gates damaged and inoperable.
20 March 97

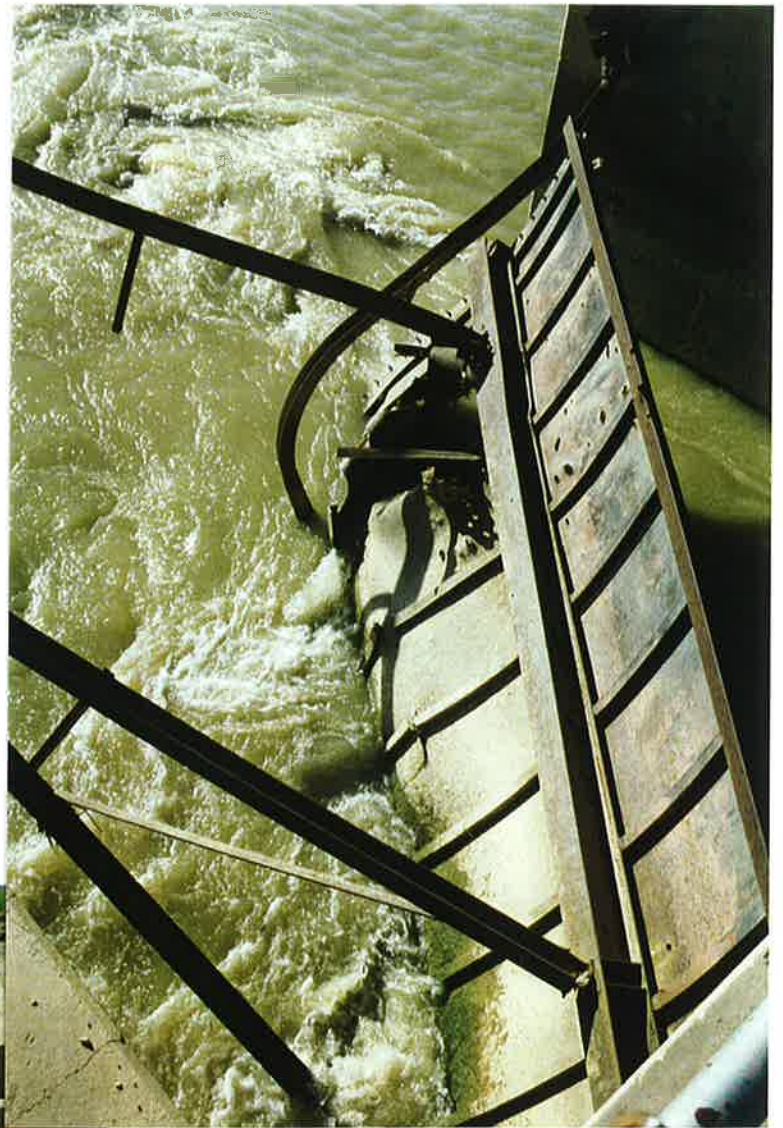
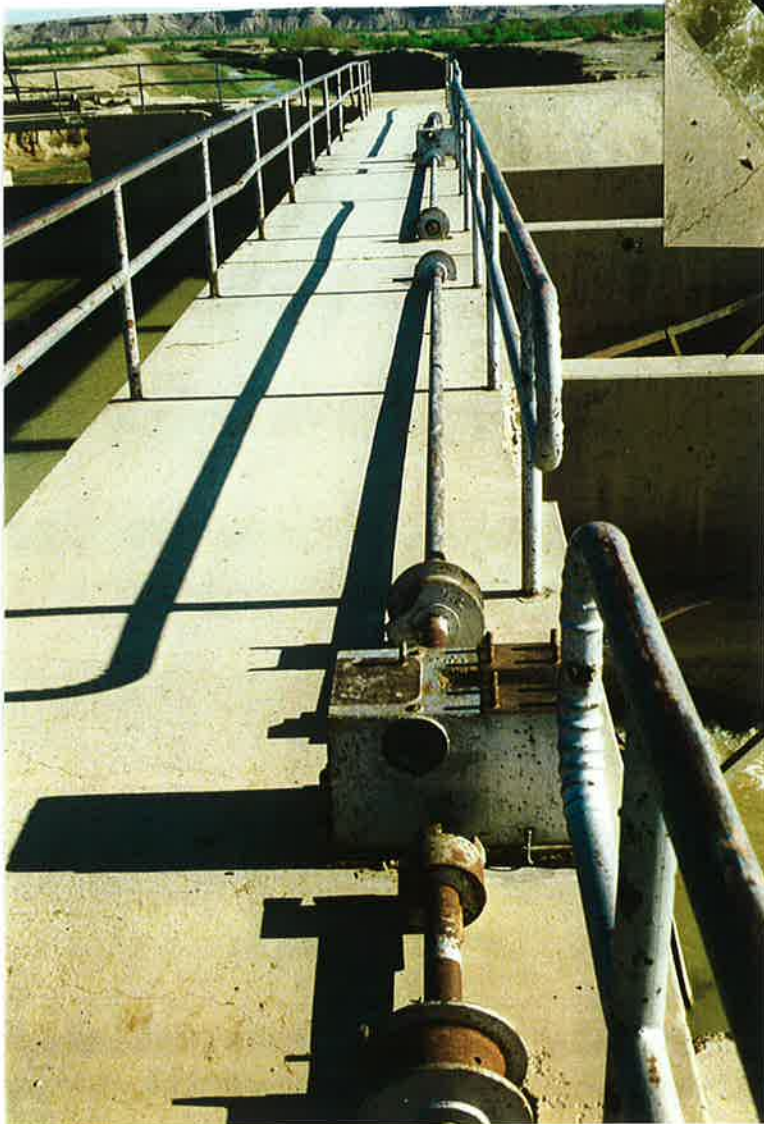
81. Damaged gate on Boghra canal control structure at Waste-way north of Shamalan diversion. See #80.

82. Gate lift mechanisms with missing parts on Boghra canal control structure. See #80 + 81 above. Waste way going off at end of walk way.

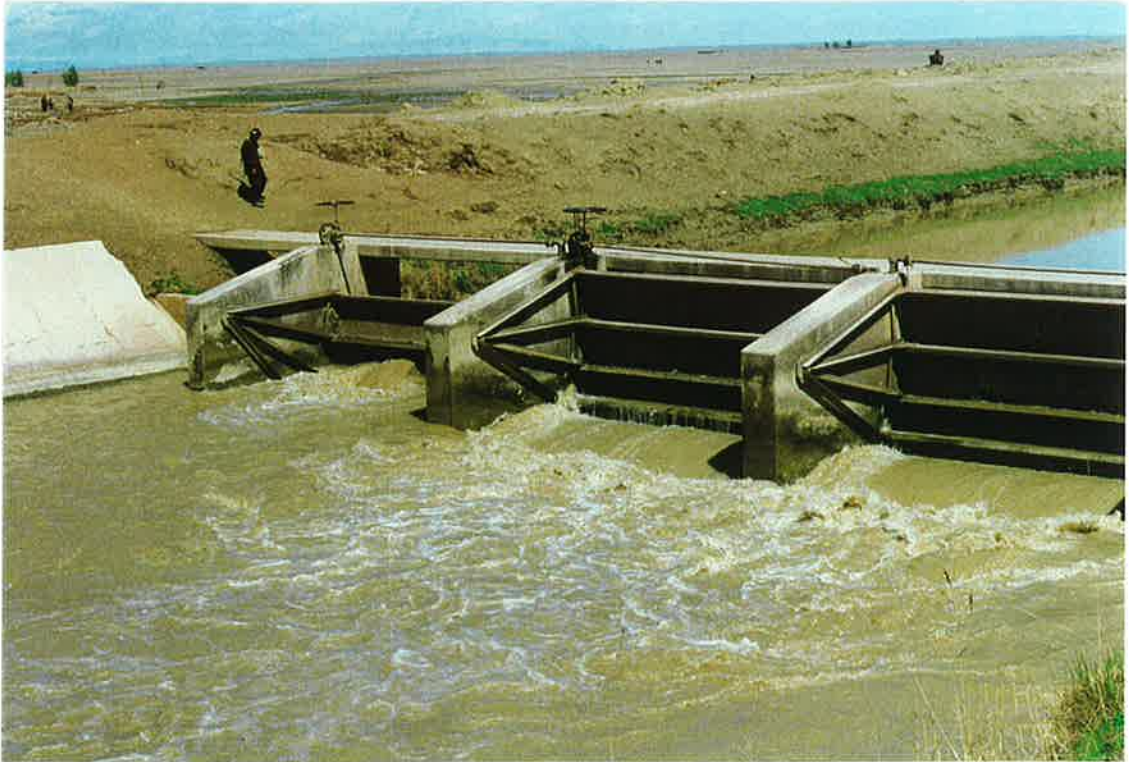
87. Control Structure on Baghra Canal at Shamalan canal intake. Gates lift mechanisms are damaged or missing

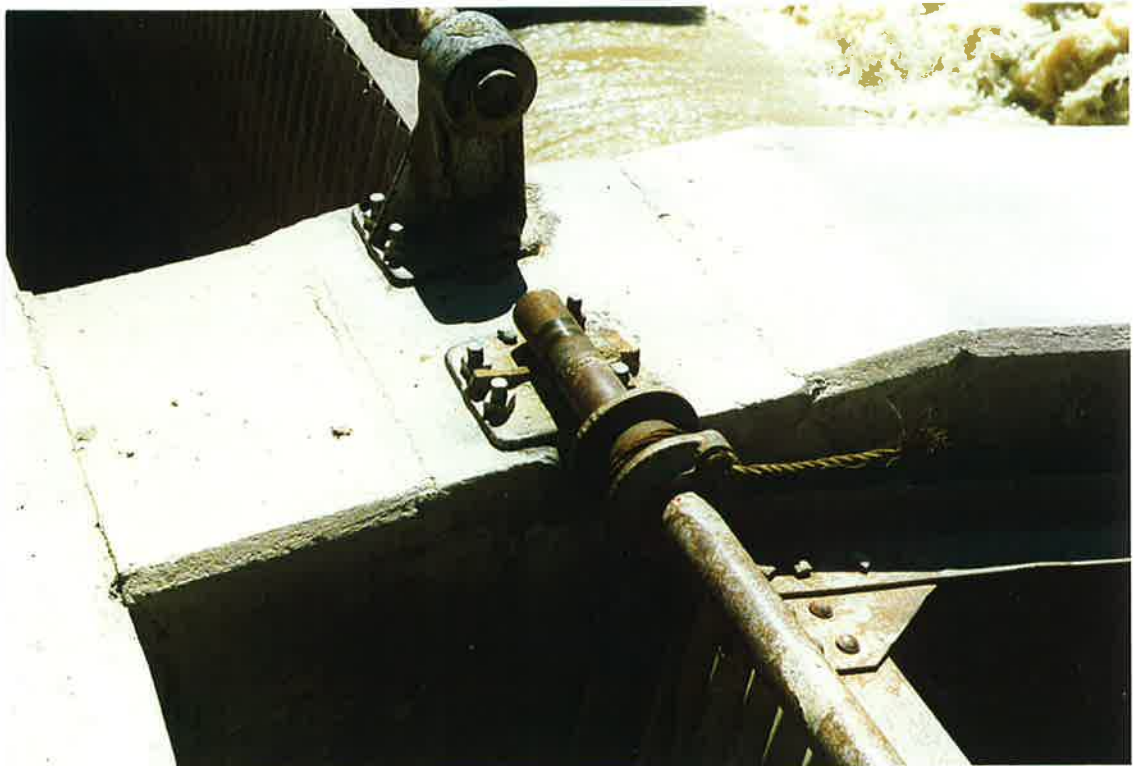
88. Gate lift mechanism part missing. See # 87 above.

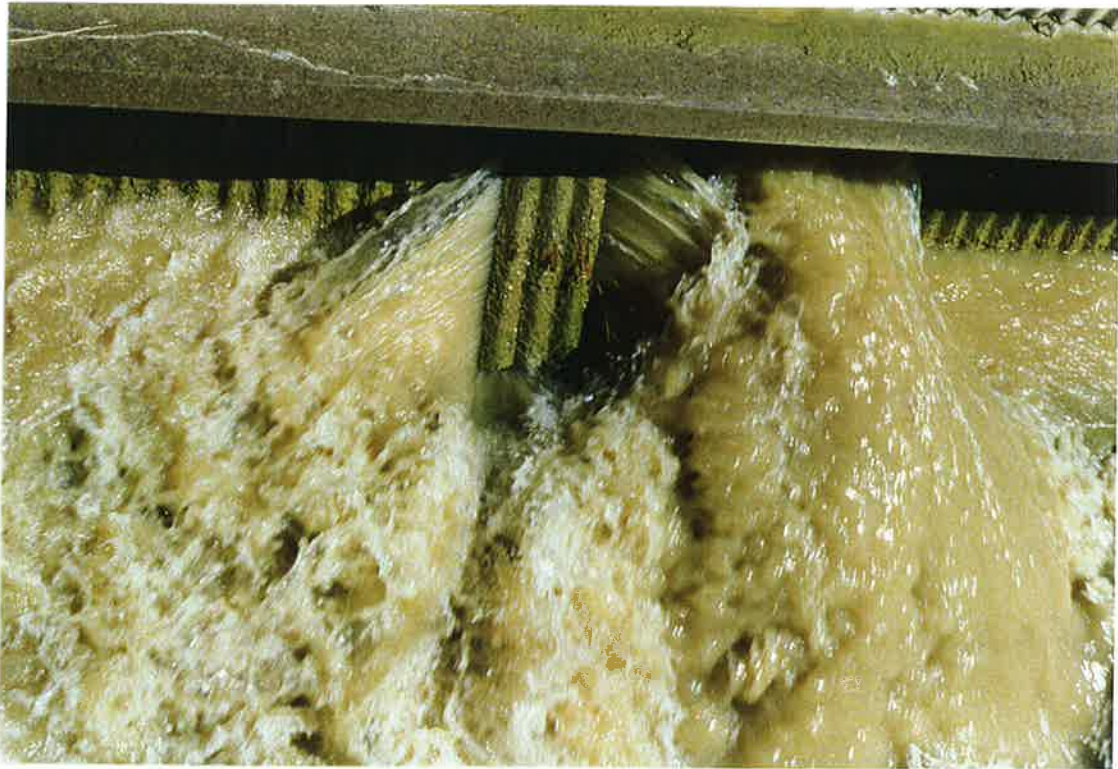
89. Damaged gate. Sec # 87-88
above. 18 March 97
