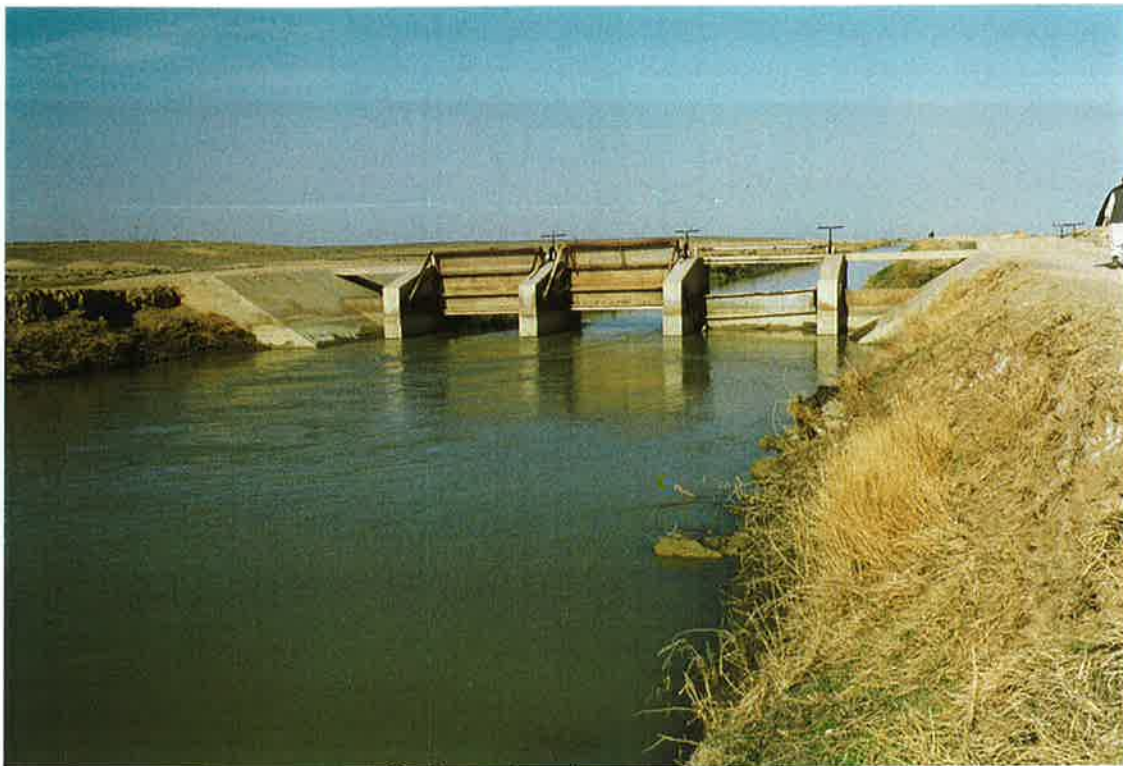
95. Control Structure on Boghra Canal at a Marja wasteway. Note washed wing on left, 22 March 97

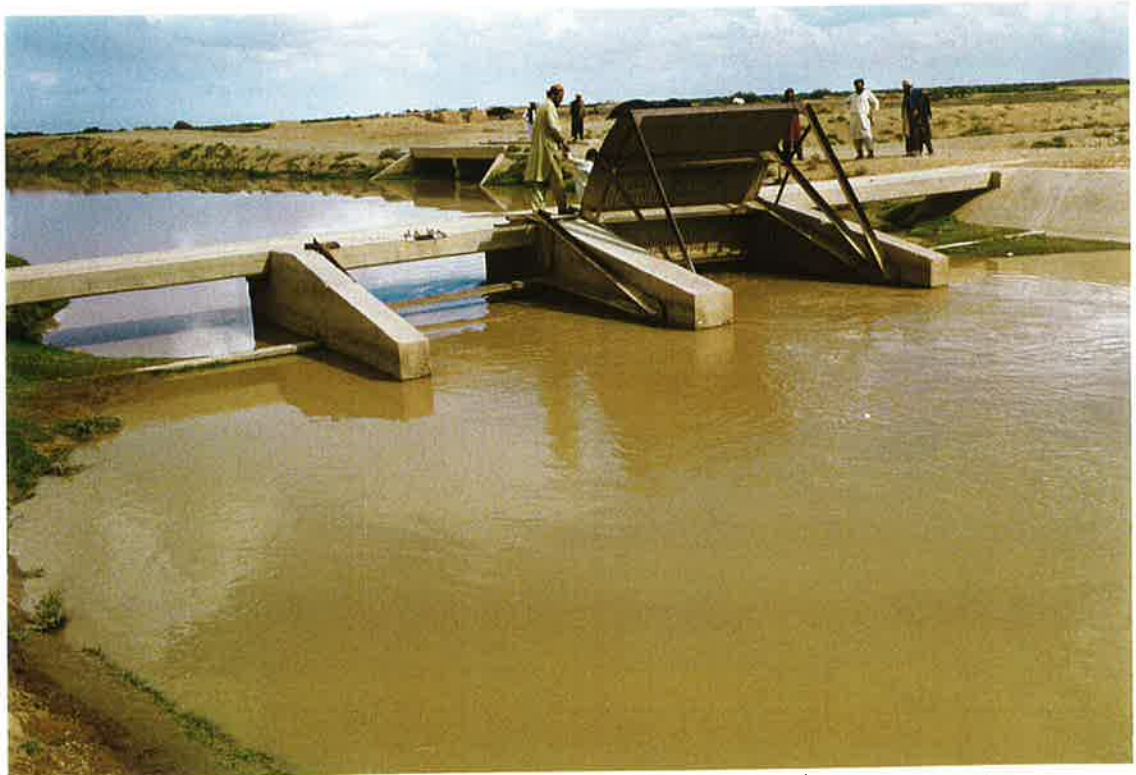
99. Control Structure at a Waste way on Baghra Canal, silted and missing gates. Near Marja. Waste way structure near top center. 18 Oct 97

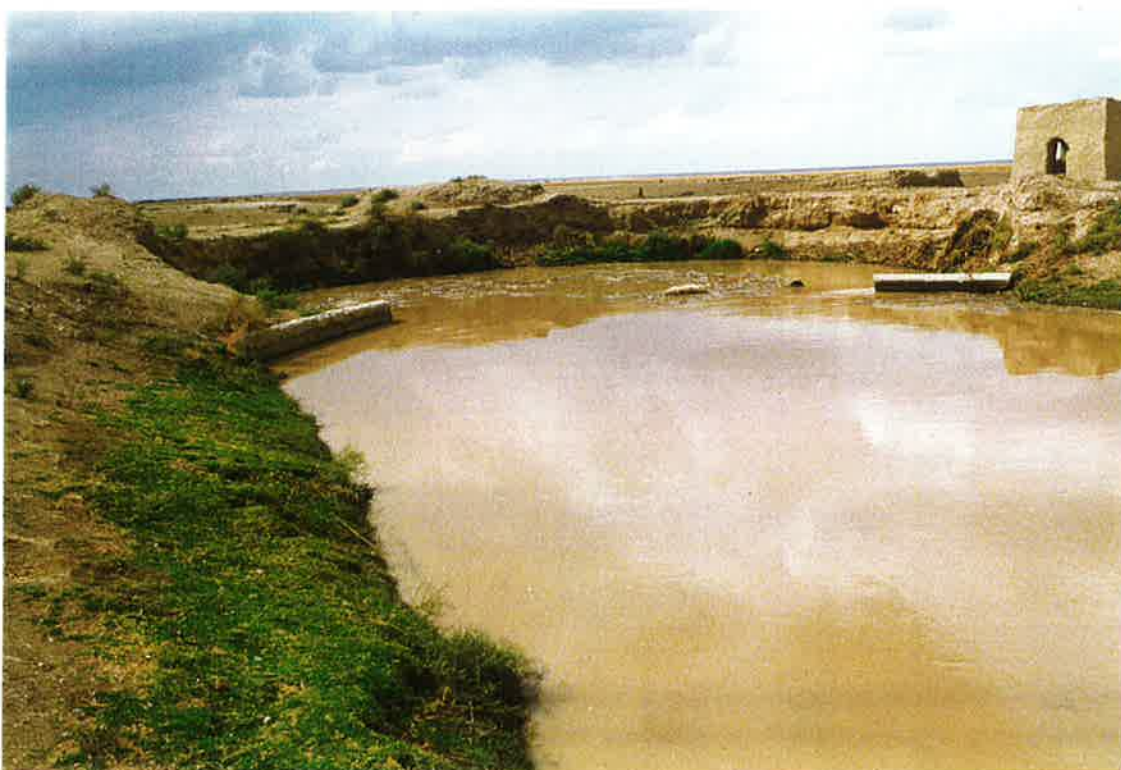
102. (below) Damaged (blasted) siphon on Boghra canal near Marja. Note silt embankment at water edge. Siphon still functions. 18 Oct 97

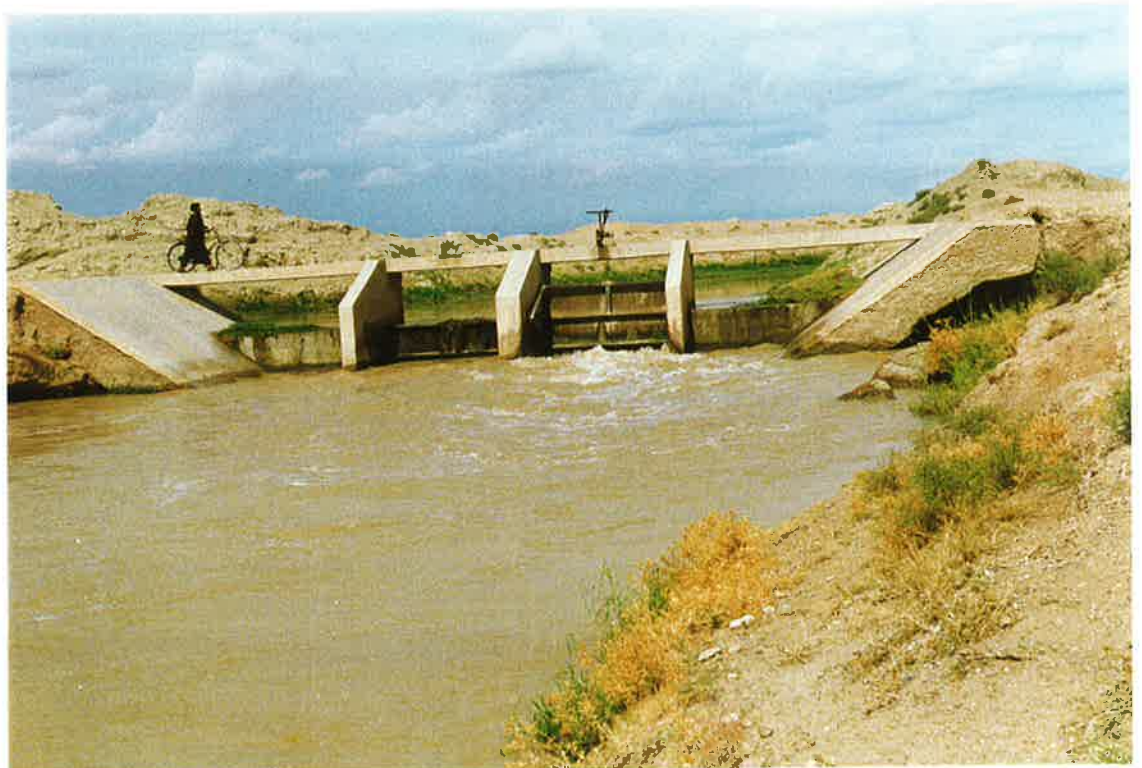
103. Damaged control structure on Boghra Canal near Marja. One gate functions. Note washed out wings. 18 Oct 97.

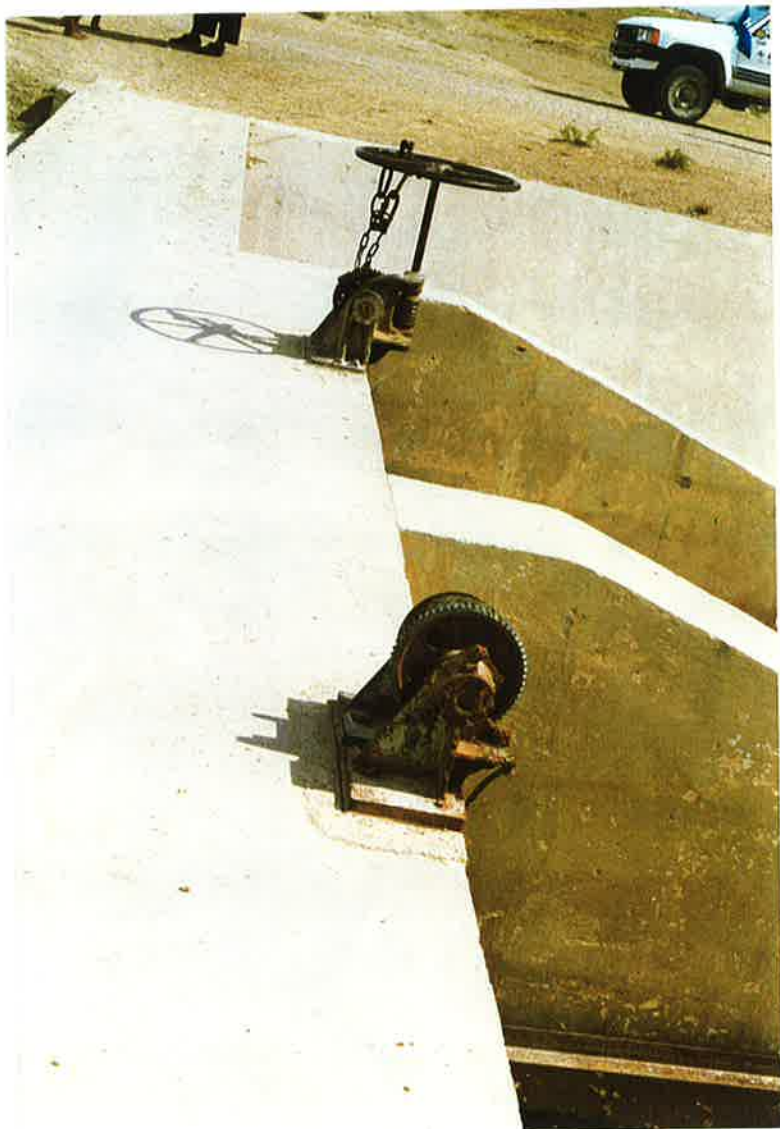
104. Locked gate lift mechanism on control structure on Boghra canal. See #103 above. 18 Oct 97

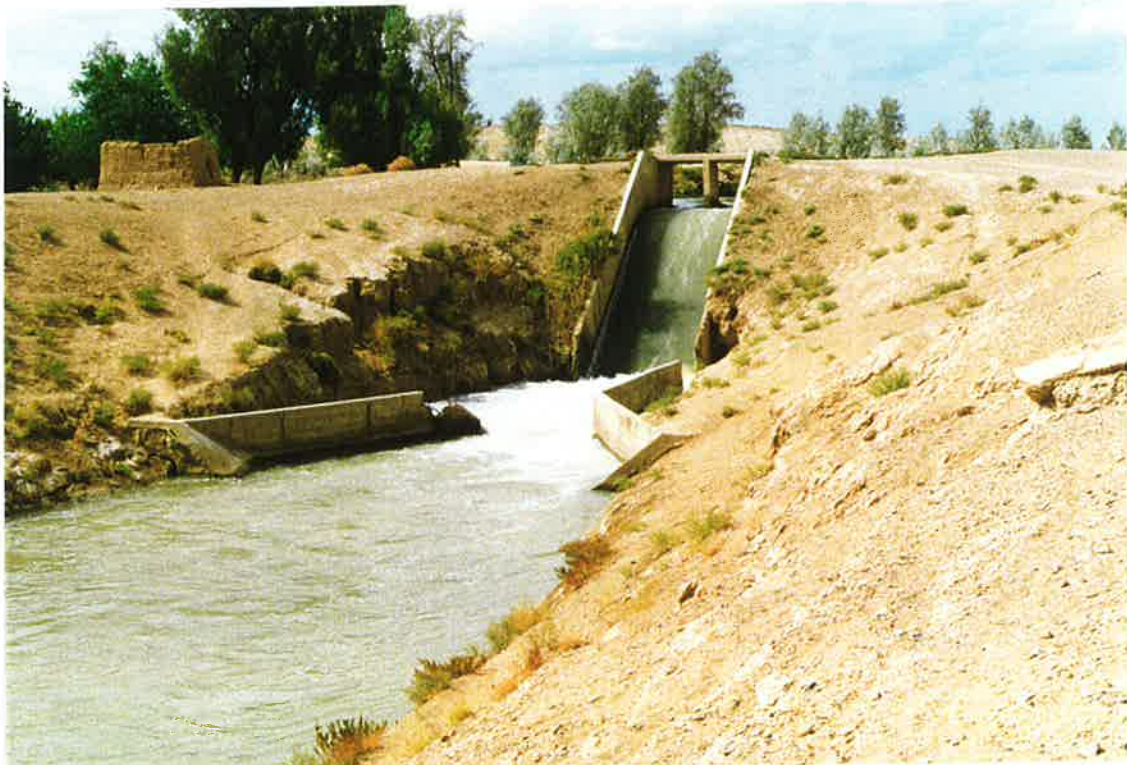
106. Damaged drop structure on Boghra canal near Marja. Note wash-out on left. 18 OCT 97

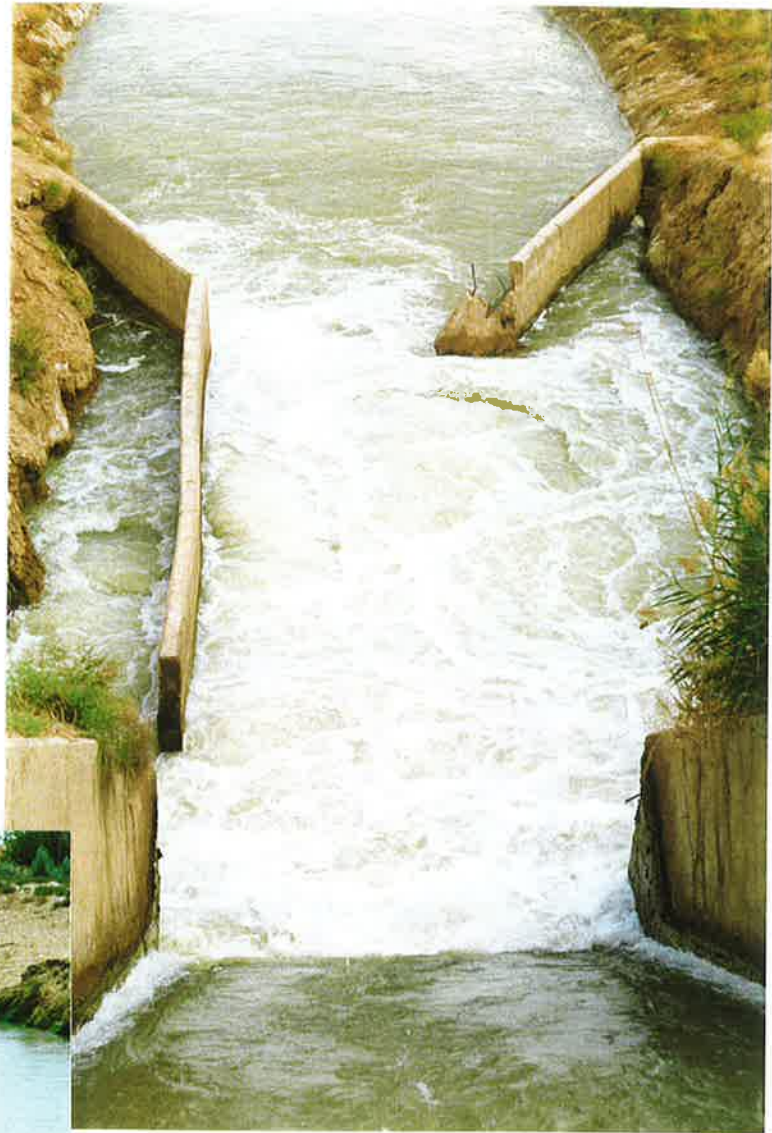
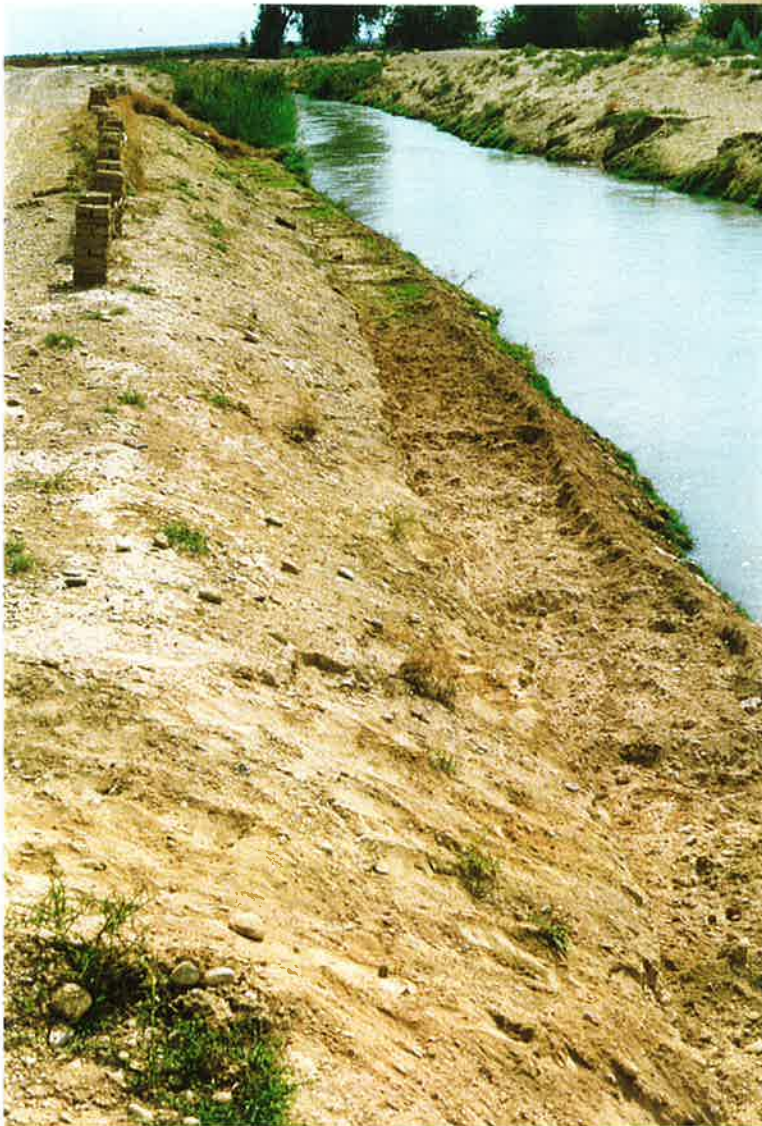
107. Damaged drop structure on Boghra Canal near Marja. See # 106 above.
18 Oct 97

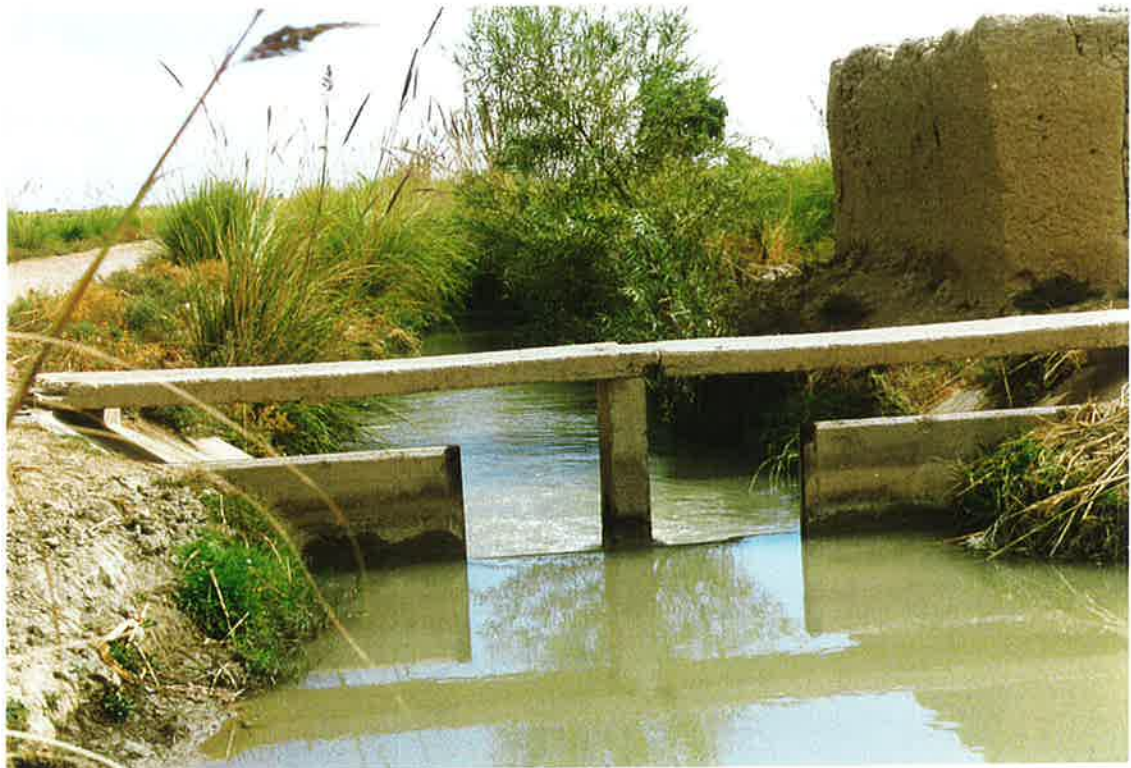
111. Central Marja over-grown channel. Gatas missing from control structure. 18 Oct 97
