**HELMAND-ARGHANDAB VALLEY  
IRRIGATION SYSTEM**

**A CHANGE ASSESSMENT: 1973 - 1990**

**DEVELOPMENT ALTERNATIVES, INC.  
and  
EARTH SATELLITE CORPORATION**

**February 1993**

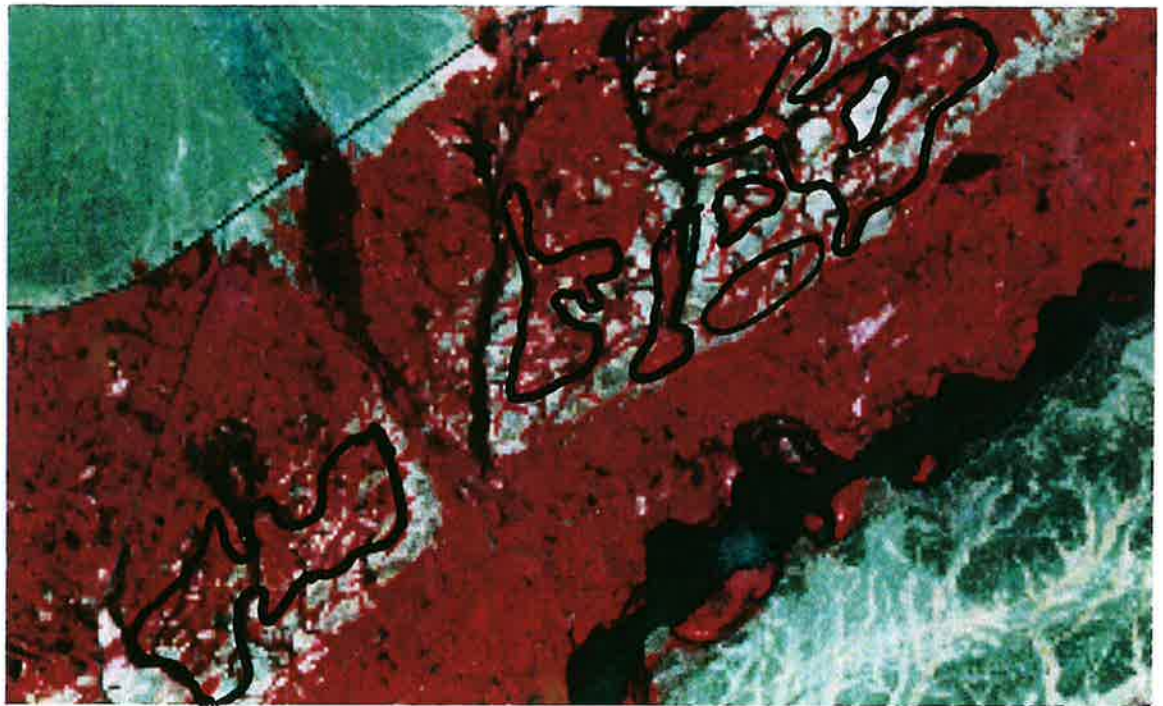
Figure 7 Study Site 1 - Northern Shamalan

The area is affected by cross drainage (from the northwest to southeast). Levees contain and channel cross drainage across Shamalan to the Helmand River. As it crosses Shamalan, the western-most streambed appears much wider and more diffuse than the others, which may indicate some damage to the levees controlling that particular streambed system. A siphon in the Boghra Canal (the dark line in the northwest portion of the image) appears as a gap in the solid dark line of the canal. The siphon is apparently functioning.

Some of the apparent increase in vegetation may be due to rainfed crops established in a wet year. In some areas, vegetation is not in rectilinear patterns, which supports the notion that some of the vegetative growth is rainfed, or weed growth, and not irrigated agriculture.

The Helmand River carried much more water in April 1990 than it did in June 1973. This is evident from the width of the river (in black) and flooding of areas adjacent to the river.

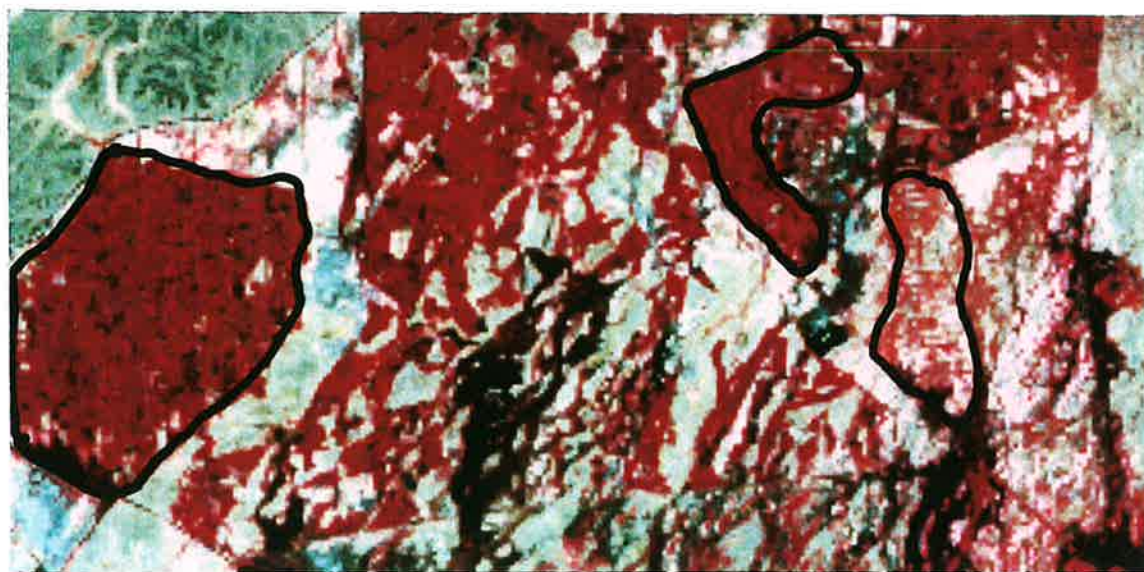
Figure 8 Study Sites 2, 3 and 4 - Northern Marja and Southeastern Nad-i-Ali

Site 3 (the northeast portion of the image) is an area of 400 hectares located in the southeastern portion of Nad-i-Ali, which has shown an increase in irrigated cropping. At one time this area was government-owned forest that was later cut down and the land distributed amongst settlers. Land is heavily farmed although there are some pockets of salinity.

Site 4 (the east-central portion of the image) is adjacent to, but outside of, Nad-i-Ali. The area was not farmed in 1973. In the 1990 image, a rectilinear pattern of irrigation infrastructure has been established but appears abandoned. This area lies between government posts and Mujahiddin positions and saw much fighting. The land has been mined and irrigation facilities are damaged. The few areas cultivated in 1990 are watered from drainage canals. The area covers approximately 350 hectares.

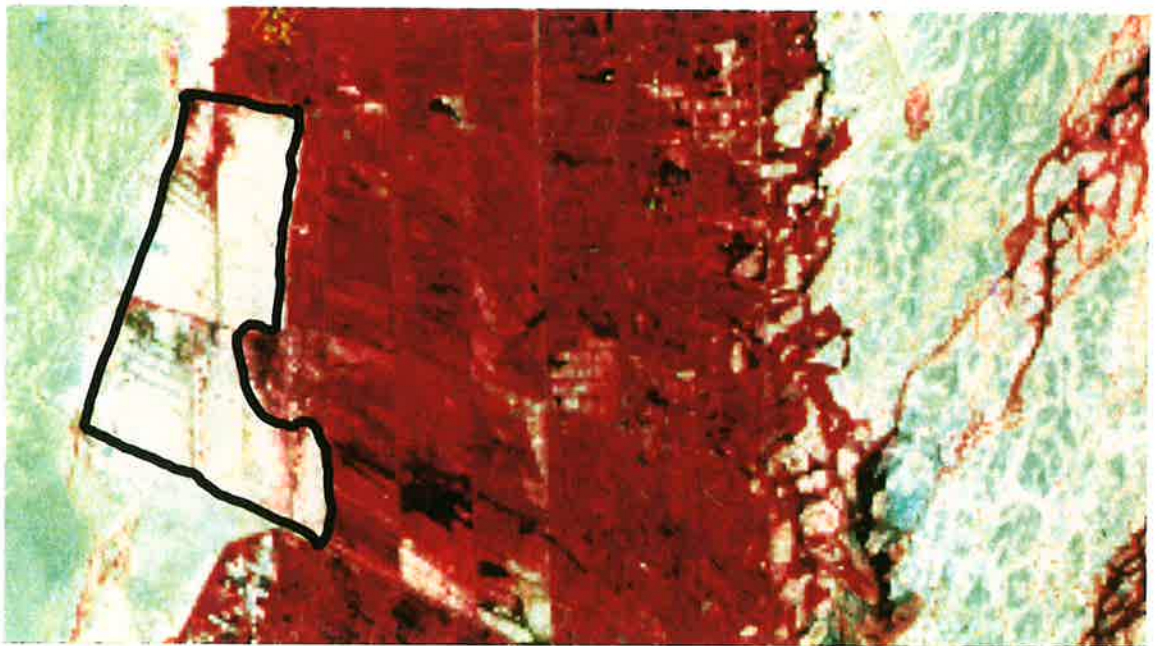
Figure 11 Study Site 9 - Western Marja

Patterns in Site 9, the west portion of Marja, appear similar to those in Site 8. In the 1973 image, evidence of recent cultivation and waterlogging can be seen. In the 1990 image, the land is abandoned and appears salinized. This can be due to blocked drainage outlets. Approximately 1,000 hectares are affected. Parallel lines visible in the imagery may be abandoned canals.

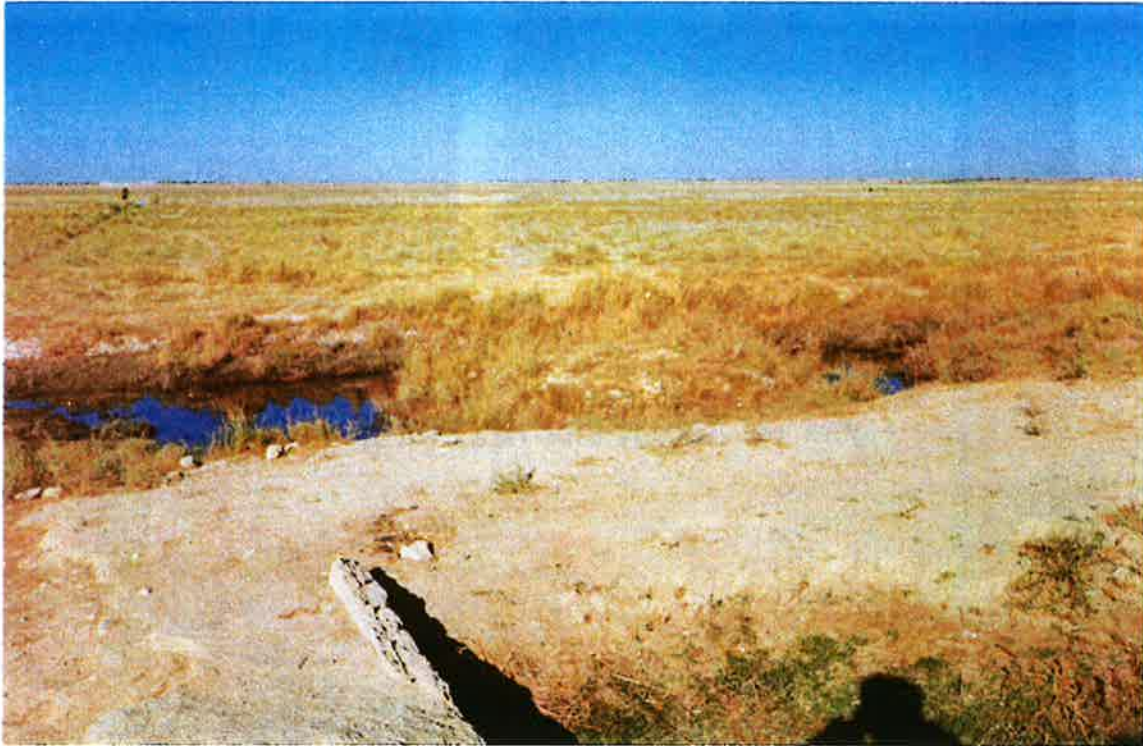
Site 14 (portions of which are shown on both Figures 15 and 17) is the largest area of change in the Helmand system. The area is located in the downstream/southwestern portion of Shamalan. Abandonment of irrigated agriculture between 1973 and 1990 encompasses more than 5,000 hectares. Most inhabitants have left the area. Rectilinear patterns of irrigated agriculture which are seen in the 1973 image have been replaced in the 1990 image by a background mosaic which appears strongly salinized. Only scattered/limited agriculture can be seen, particularly along canals and drains. Prior to the war, the area had been irrigated by the Shamalan Canal which was damaged by military activity and by floods. Inadequate canal maintenance led to constraints in water supply. Lack of maintenance of drains helped give rise to pockets of salinity. The field team that visited the area in December 1992 brought back photos which showed patches of salinity and adjacent standing water (groundwater) that was nearly at the level of the soil surface. (See Figure 16.)

Figure 16. Photograph taken near Site 14 which shows standing water and adjacent patches of salinity.

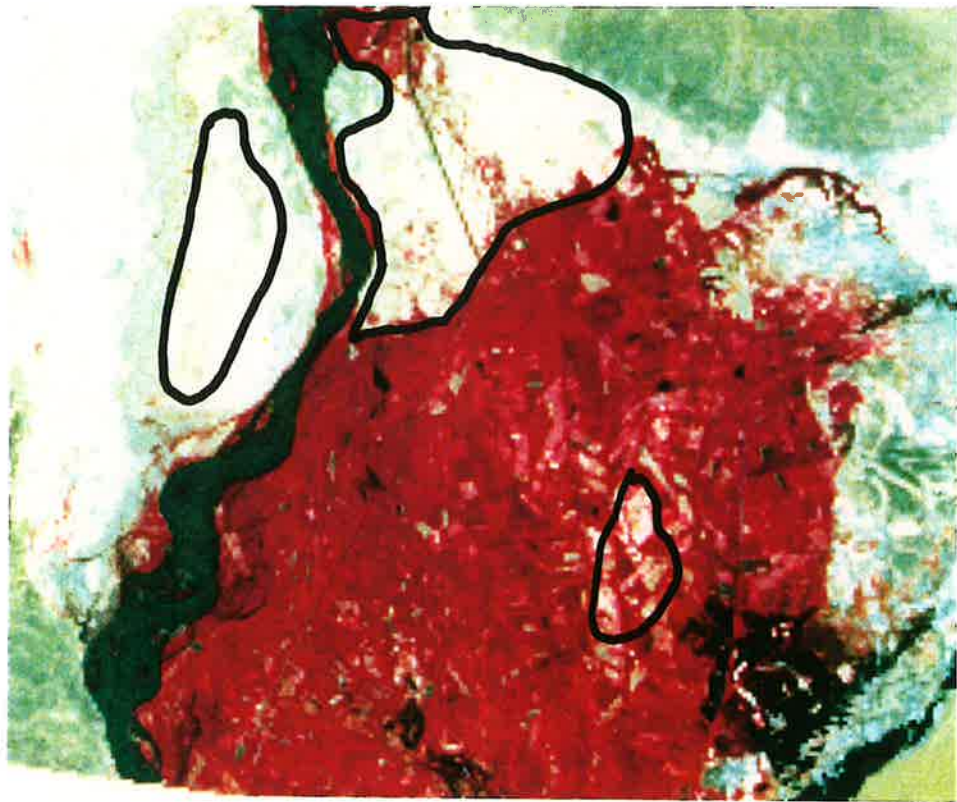
Figure 17 Study Sites 14, 15 and 16 - Southwestern Shamalan, Northern Darweshan

Site 15 is east of the Helmand River in the north part of the Darweshan Project area. This area saw severe fighting during the war. Farmers became refugees. Canals, watercourses, and drainage systems were not maintained and are presently silted up and choked with weeds. There was deliberate damage done to canal gates, and in 1990 floods further damaged the irrigation system. Very little water can be supplied to this area. In late 1992 there has been a return of refugees to this area and attempts are being made to repair the irrigation system. Approximately 1,270 hectares have been affected.

Site 16 can be seen in the central portion of the image. This is an area of approximately 200 hectares which has gone out of production due to blocked drainage channels and resulting salinity.
