2598 Big Thompson
Drake, CO 80515
10 February 1998

R. James McHugh
Counselor for Narcotics Affairs
American Embassy
Islamabad, Pakistan

Sorry for the delay in getting this information to you. In this letter I will outline what I saw on my brief visit to the Helmand region in mid-October 1997 with a somewhat expanded discussion of the issues. There are also suggestions for small projects and small items that need funding. I have included a set of copies of photographs that I took both during my March '97 and October '97 visits. Each photo is dated. Some descriptive information is also included. Some of the photos relate directly to the issues under discussion. If you would have need for a print of any of the photos, let me know. Hopefully this combination of documentation is not too confusing but it does contain a lot of information. The trips to Helmand would not have been possible without the support and sponsorship of Engineer Sayed Jawed of Helping Afghan Farmers Organization (HAFO) whose main office is in Peshawar.

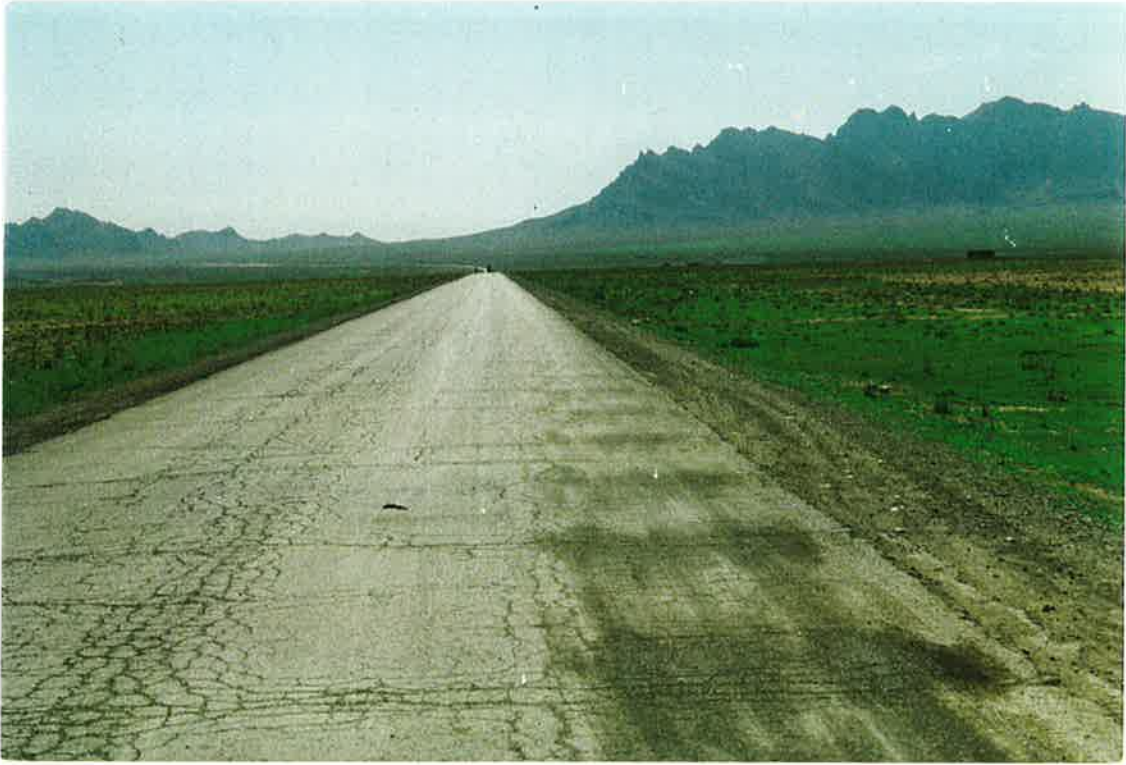
The asphalt highway between Chaman and Kandahar, originally built by MKA, is in even worse condition over most of the distance with shifting road bed more than just a rough surface. Perhaps it had more tank traffic being near the border. My photos show some of the good sections (Photos No. 1 and 2).

1. Chaman to Kandahar highway 26 March 97

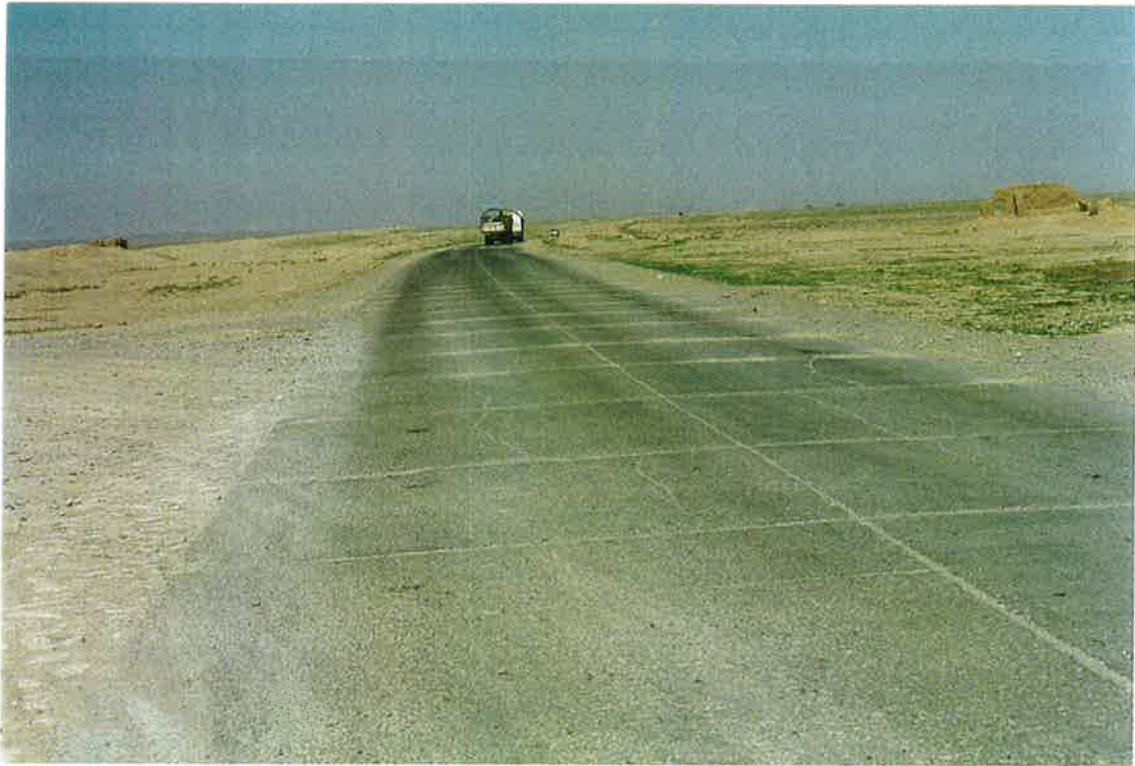
There are several highway photos of the Russian-built concrete surface between Kandahar and Girishk (Photos No. 5, 6, 7, 8). The road surface worsened between March and October '97. The truck traffic seems to have increased during this period (but I have little to compare it with) with very heavy loads of train wheels and other

5. Kandahar to Herat highway at Lashkar Gah turn-off, 17 March 97

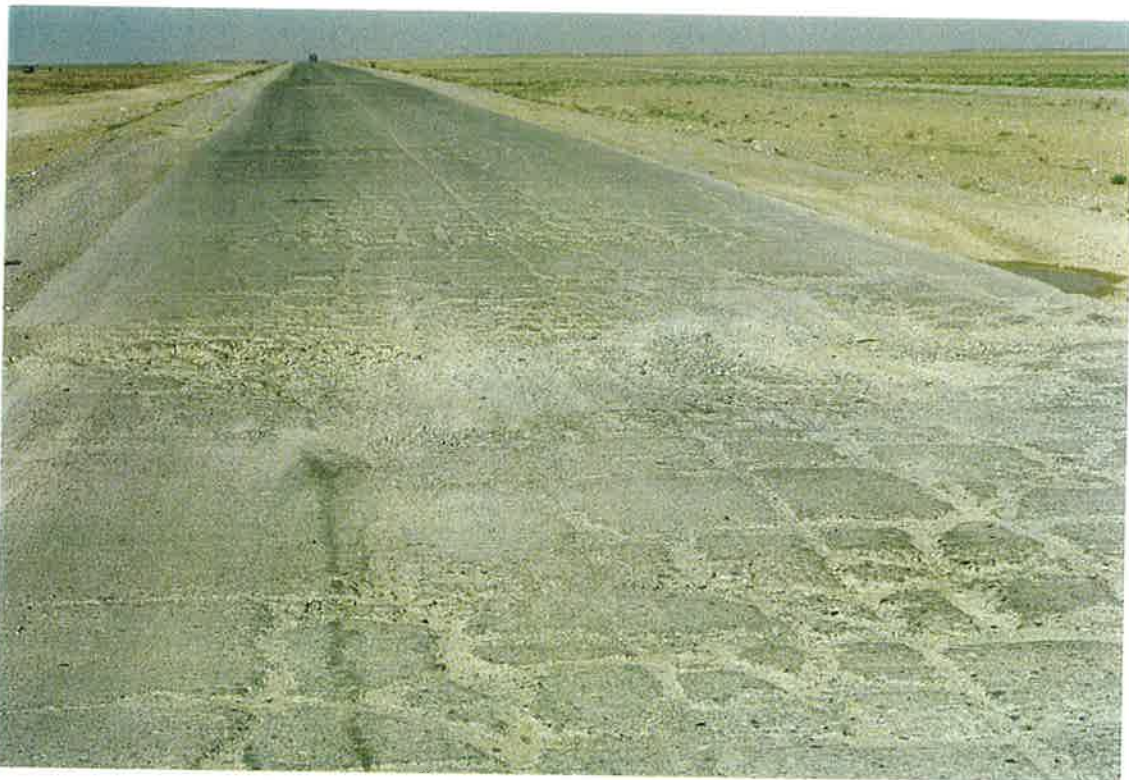
scrap metal apparently being shipped between Turkmenistan and Pakistan smelters. There were also shipments of TV sets and other electronics on the road (from Iran?). The road surface break up is likely the result of a combination of the present overloaded traffic and earlier preparation by Russian tank traffic. Nearer to Kandahar, the culverts blasted at the time of the Russians have been repaired, are being repaired or have been filled in but without repair of the concrete road surface. This highway surface, as you experienced, is exceedingly rough. This rough surface is very hard on all types of vehicles, tires, shocks, springs, etc. and costly for vehicle owners. Where possible, much of the traffic moves parallel to the main road surface.

6. Kandahar to Herat highway broken road surface 23 March 97

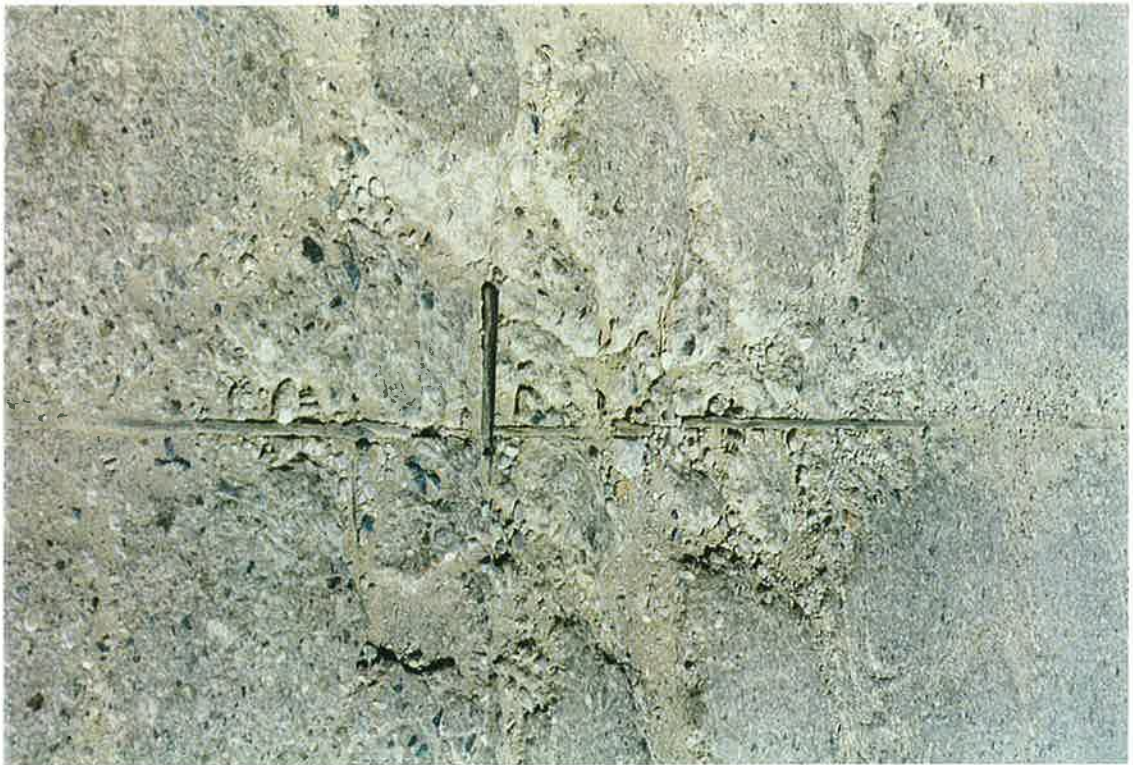
Even where this road surface is at its best, there has been considerable flaking of the concrete along the expansion cracks across the highway resulting in a rhythmic bumpy road surface.

7. Kandahar to Herat highway broken road surface, close-up.
23 March 97

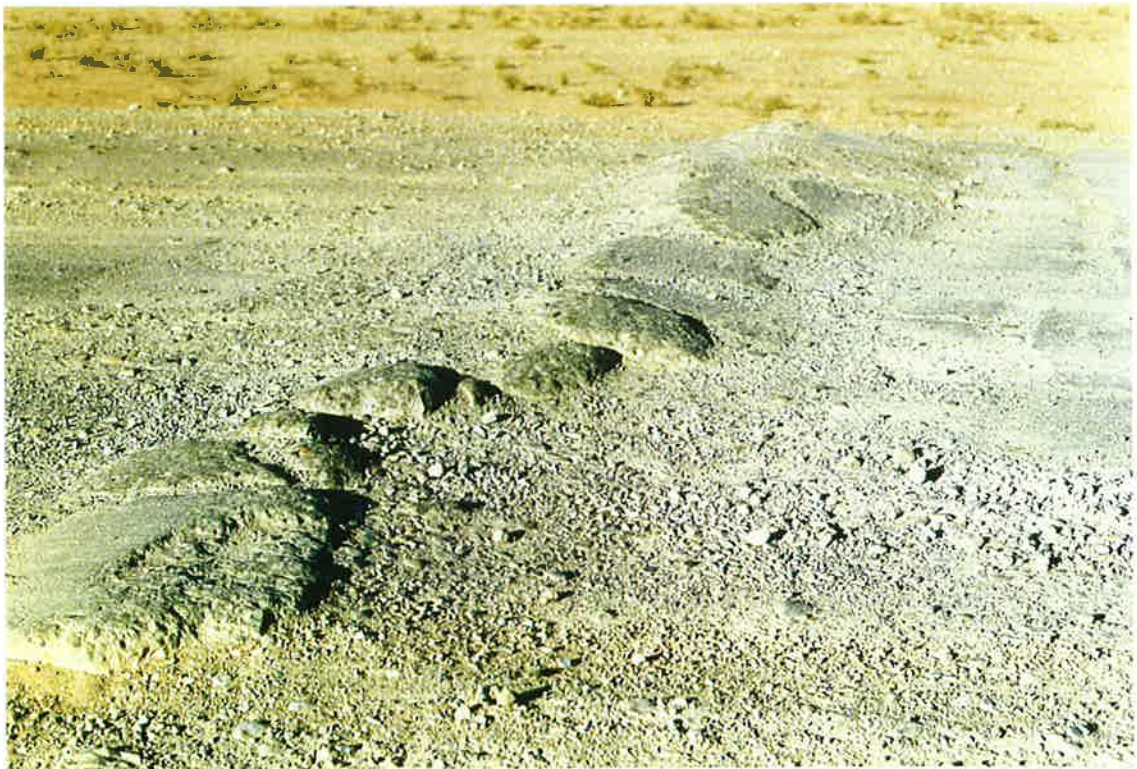
8. Kandahar to Herat highway broken road surface 20 Oct 97

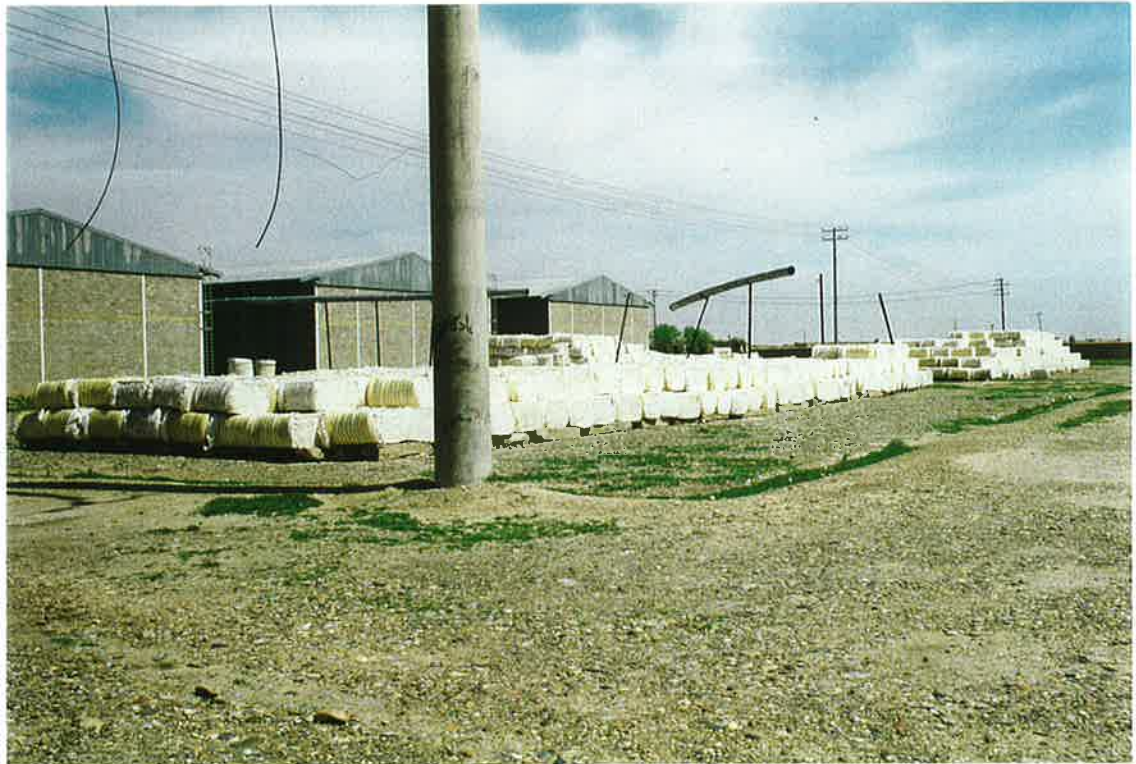
11. Lashkar Gah cotton gin, 1996 cotton crop. 22 March 97
Cut power lines on right.

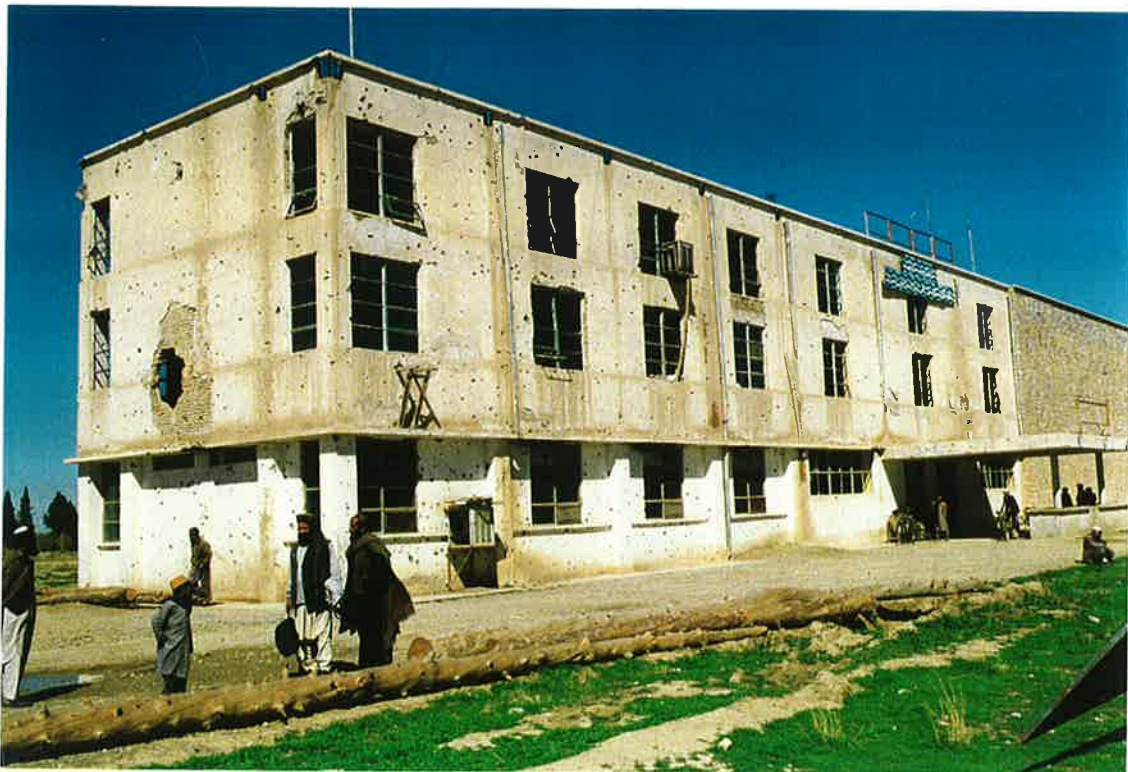
16. HAVA office building in need of repair. 20 March 97

The HVA building was damaged before the arrival of the Taliban (Photos No. 16 -22) but some offices are still in use, and as noted, HVA still functions to some extent. There is usable office space in the HVA building, although in need of repair. The Engineering Section still has furniture. As previously noted, the archives of original construction drawings for the irrigation system is well-maintained by the original

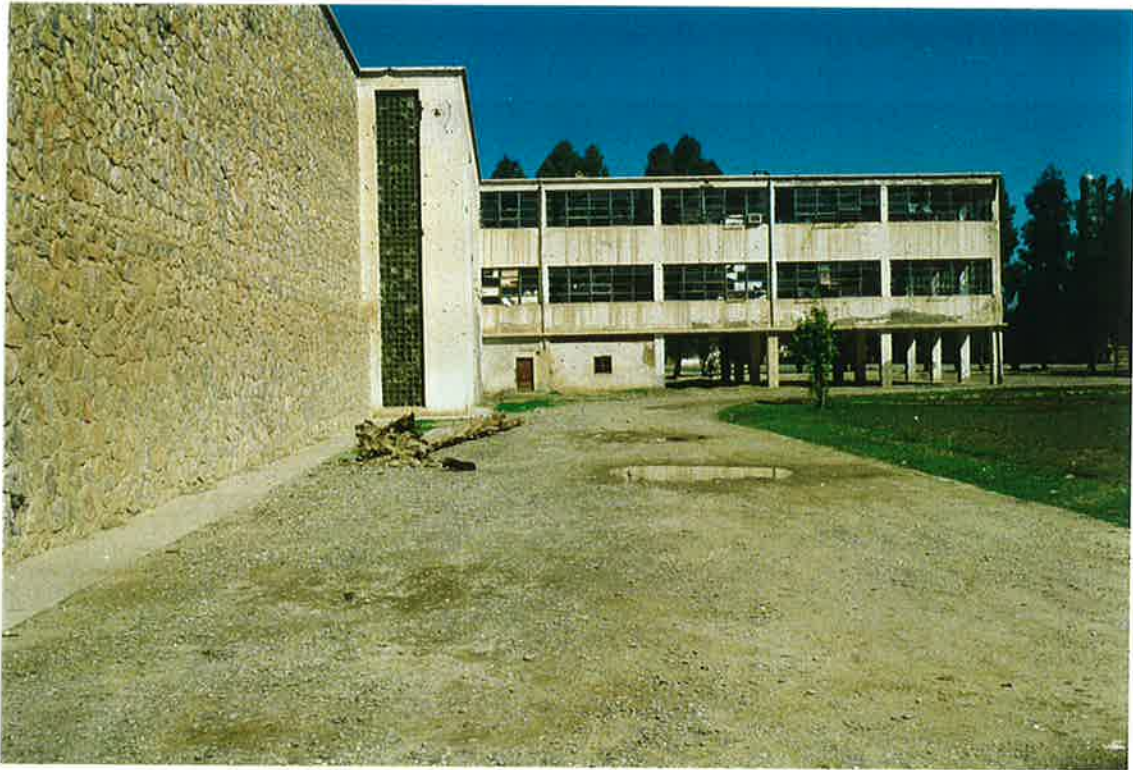
17. Engineering section wing of HAVA building. With windows blown.
20 March 97

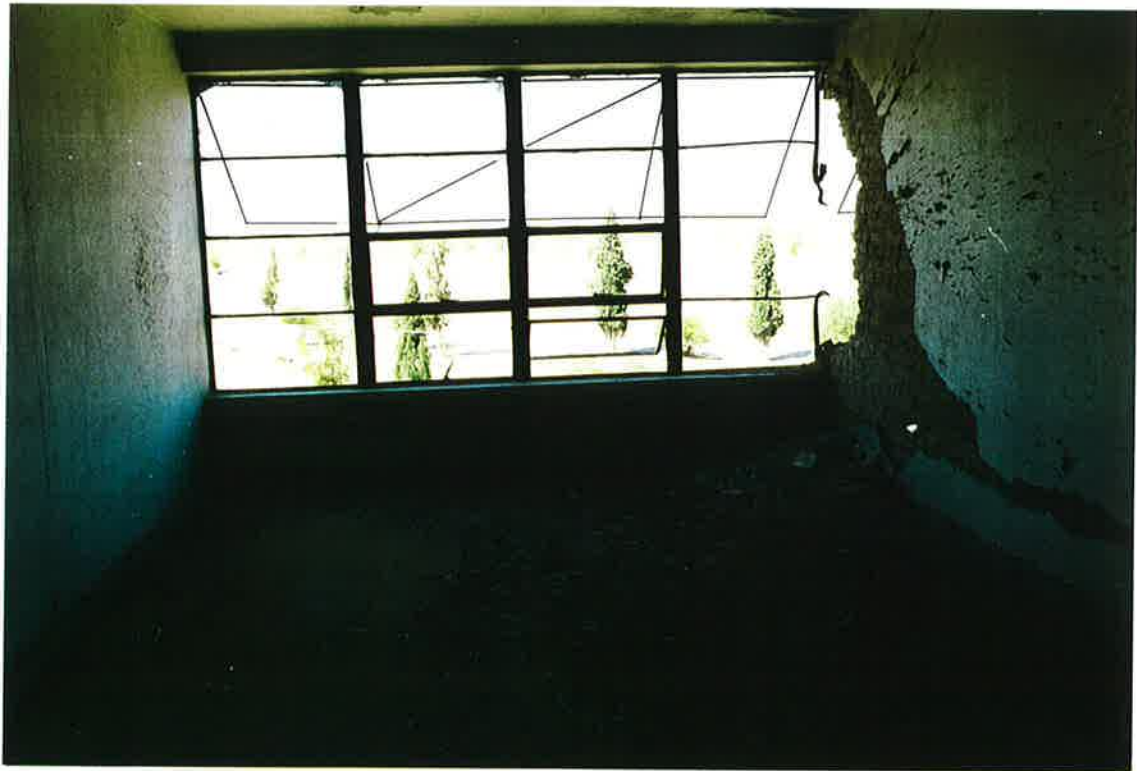
18. Damaged office in HAVA building. 20 March 97

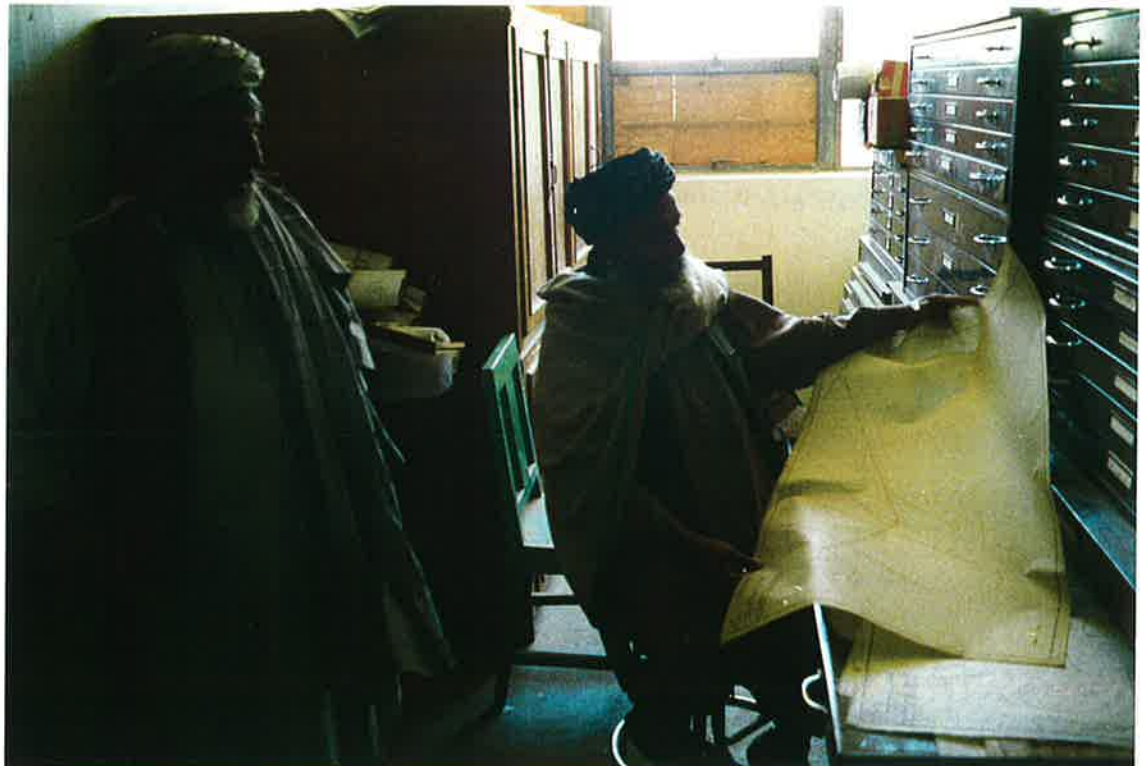
keeper (Photo No. 20). The archives for documentation still exists but is in need of glass to replace blown out windows and a lock on the door. The walls are undamaged. This documentation source includes, among other things, air photos of the irrigation system before the war. The importance of these archives is apparently not well understood by the Taliban. A small sum of money could replace blown-out windows and add a padlock to the door to preserve this documentation center, small as it is, for future reference. The technical documentation observed dates from the mid-1940's. The complex of engineering offices and the large drawing room, with drawing tables intact, would make a great training facility (Photos No. 22 - 23).

20. HAVA building archives of original construction drawings for irrigation system. 20 March 97

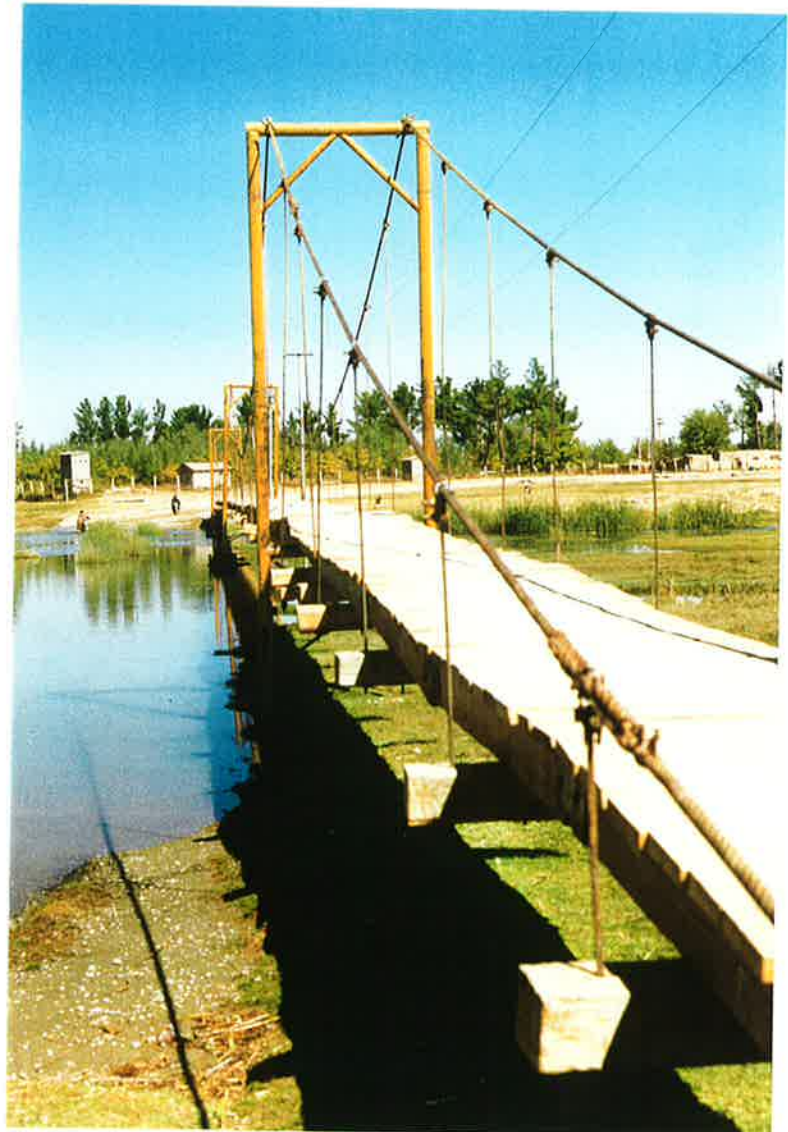
26. Chan-i-Anjir wash
suspension bridge
20 Oct 97
Repair Funded by U.N.

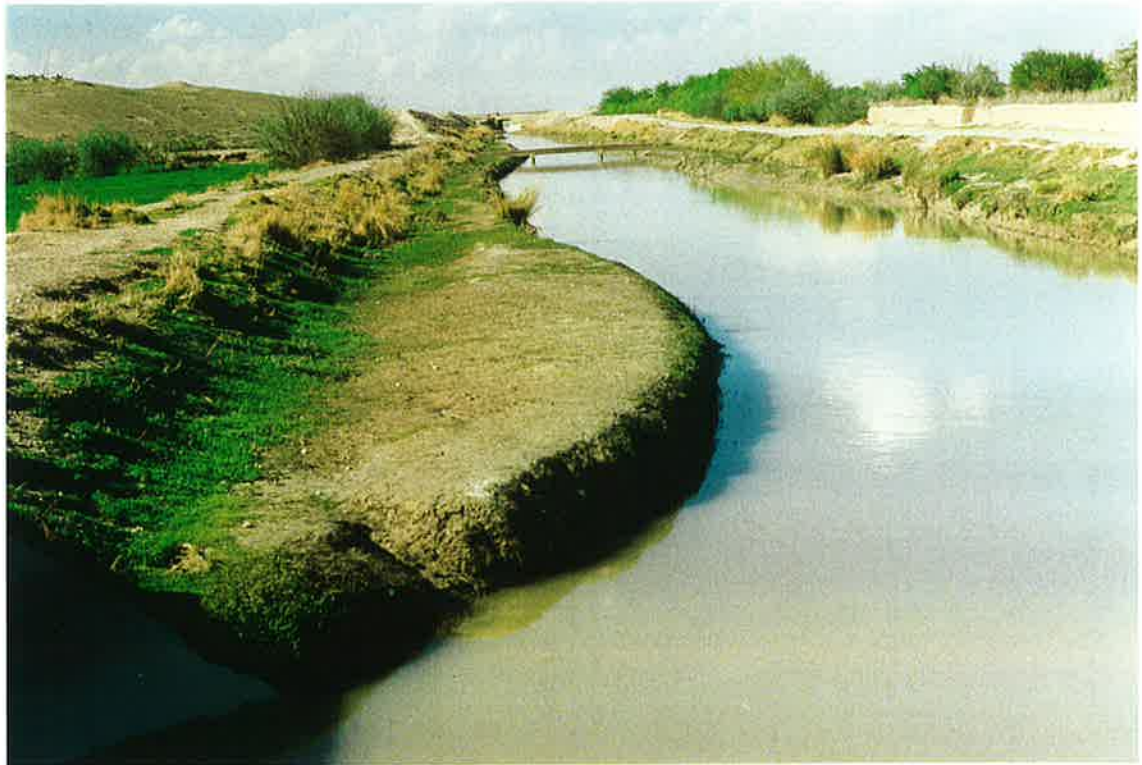
32, Shamalan Canal looking north at S-10.7 lateral intake. Note silting, center. 21 March 97

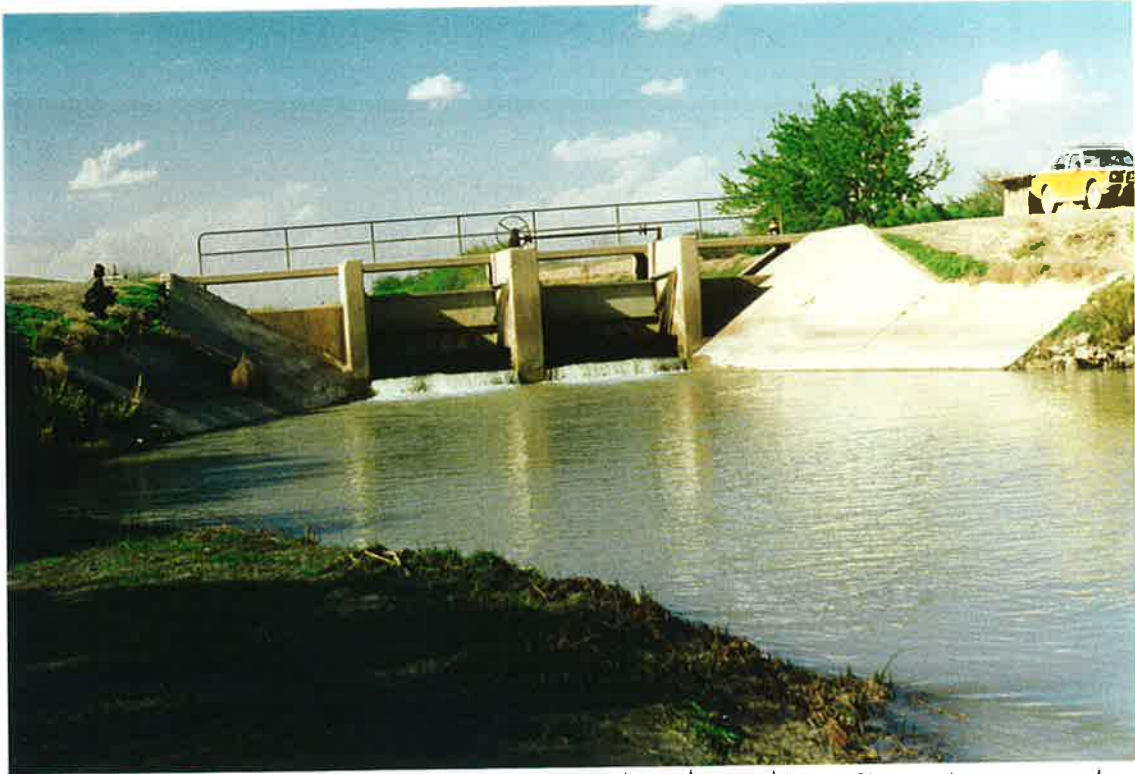
33. Diversion structure for S-10,7 lateral on the Shamalan canal. Gates closed. Lift mechanism not functioning. 21 March 97

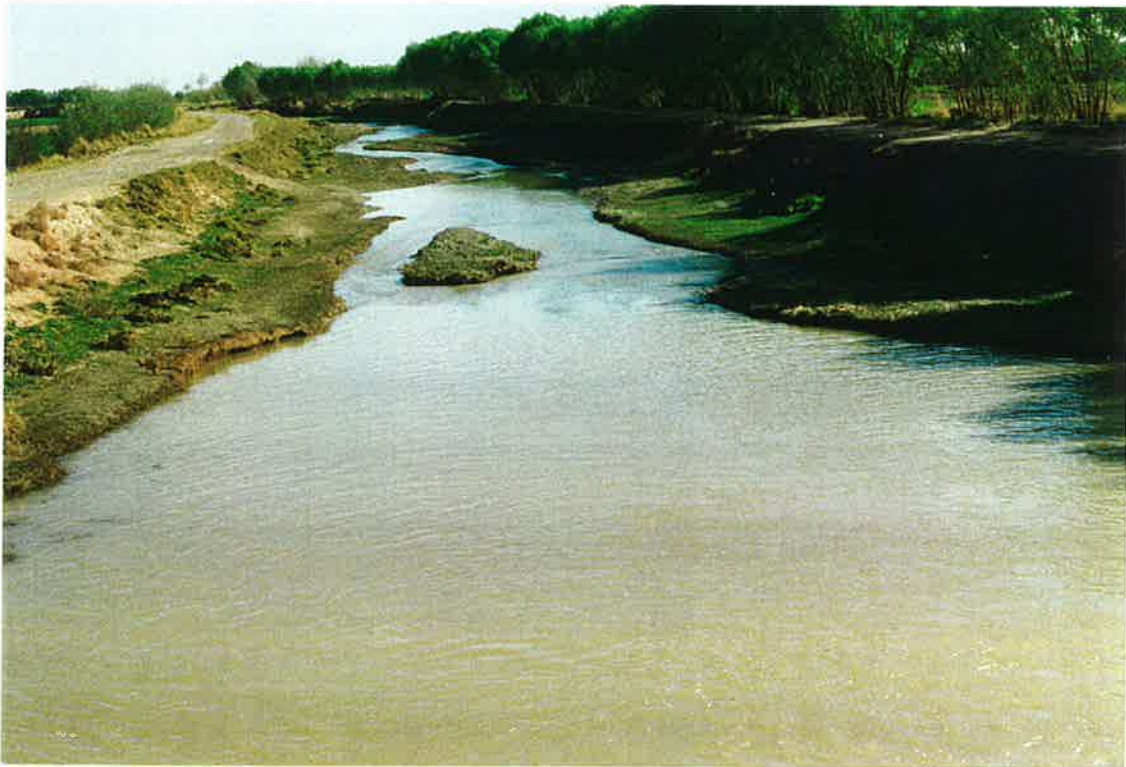
34. Shamalan canal looking south at the S-10,7 lateral intake. Note silting. 21 March 97

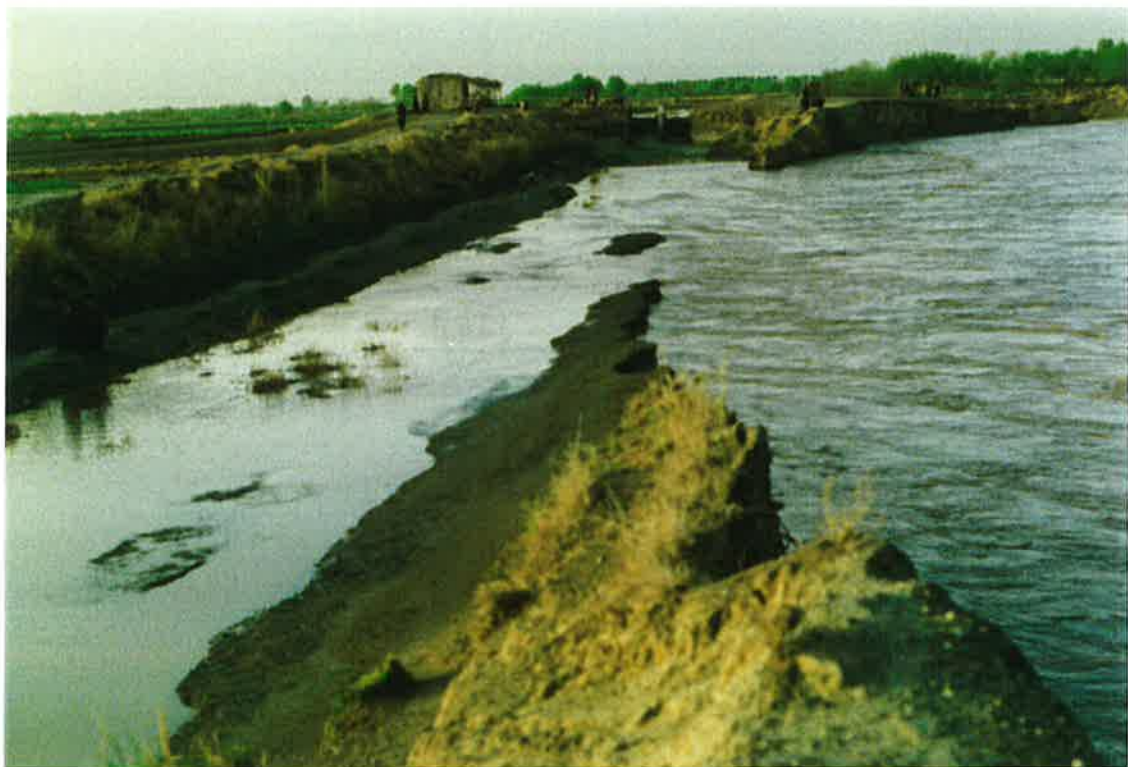
The Shamalan Canal has been breached by the Helmand River in three places (Marked in red on Map No. 2; Photo No. 36) along the unused section. One breach was repaired by Mercy Corps two or three years ago. The other two breaches occurred during 1997 and have not been repaired. If these washed out areas are not repaired in the near future and protected by gabion dikes, this section of the Shamalan Canal will likely become unrepairable and unusable. The expanded flooding each spring will also quickly take out sections of rich farm land in this Helmand flood plain as it did in the area of the repaired section of canal.

36. Helmand River (on right) at wash out of Shamalan canal just below Waste way #1, 17 March 97

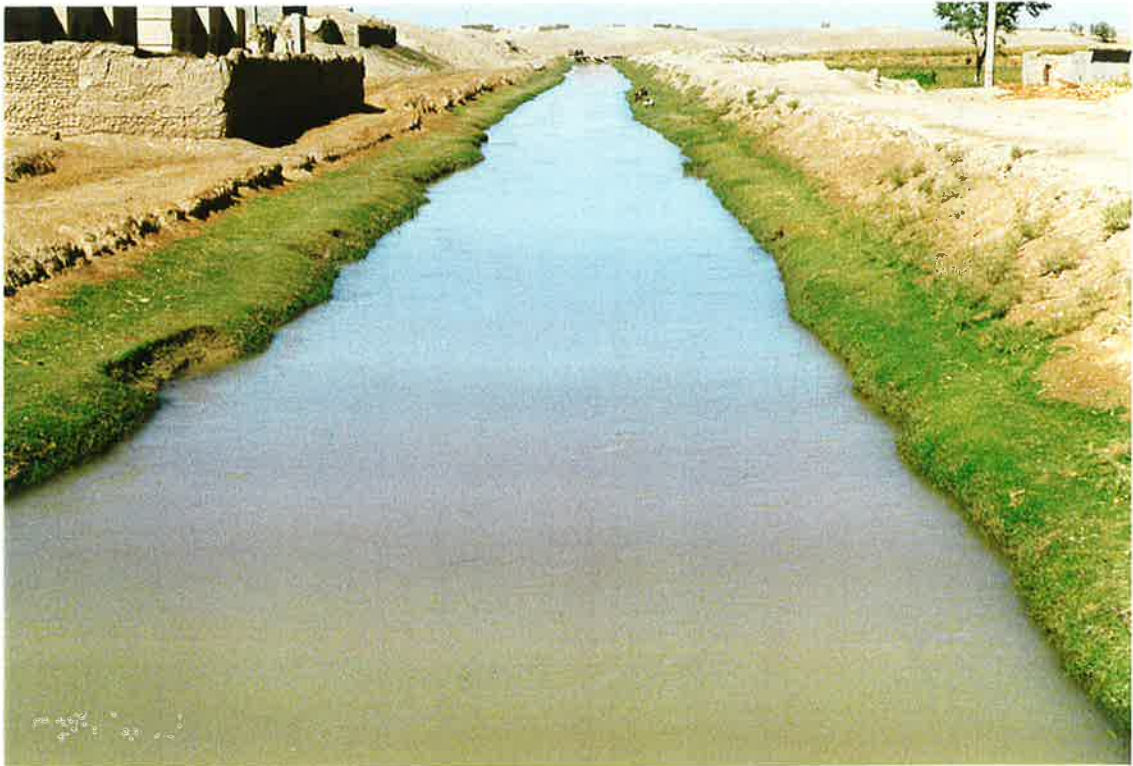
The S-10.7 Lateral is a very important water source for the Shamalan region. It is roughly 37 km. in length. There is a photo included (Photo No. 40) of this lateral taken from the Marja to Lashkar Gah road just west of Lashkar Gah. It is badly silted up and in need of cleaning. There are two other photos (Photos No. 38 - 39) of the S-10.7 Lateral taken in 1972 at the time of its construction. The S-10.7 Lateral can be closed down during several of the cold months when irrigation is not required, when the cloudy weather occurs and when the limited rain for the region falls. Given its size and depth, this lateral could be cleaned with hand labor. As a pilot project, the cleaning of the S-10.7 Lateral could tell us much about the potential for the use for hand labor in the irrigation system and its effects at the present time. Given the experience in the use of hand labor in the past in Helmand, the potential is very positive.

40. The S-10.7 lateral at the Lashkar Goh to Marja road in Bolan. The green grass is on silt. 20 Oct 97

Eng. Jawed and I recently completed a cost estimate for cleaning the 37 km. of the S-10.7 Lateral under HAFO supervision...approximately \$90,000. We estimate that

the work could be done by about 500 men in less than 90 days. And this is a generous estimate including the tools, supervision, work, etc.

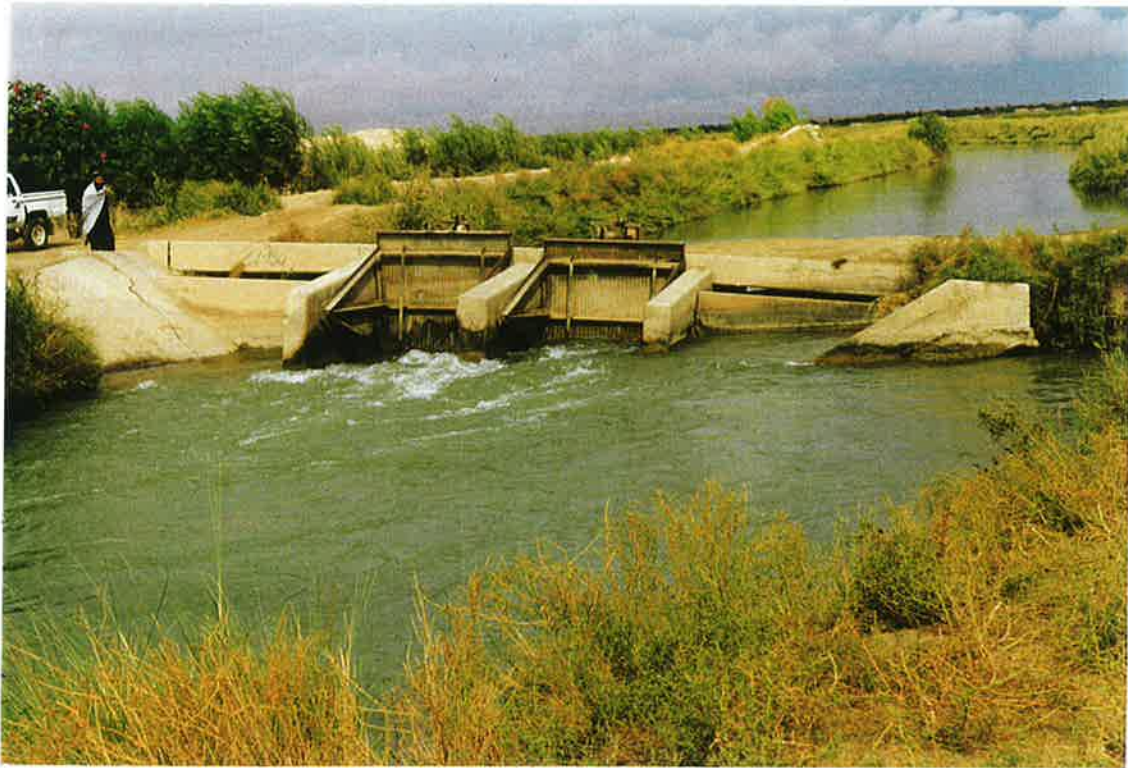
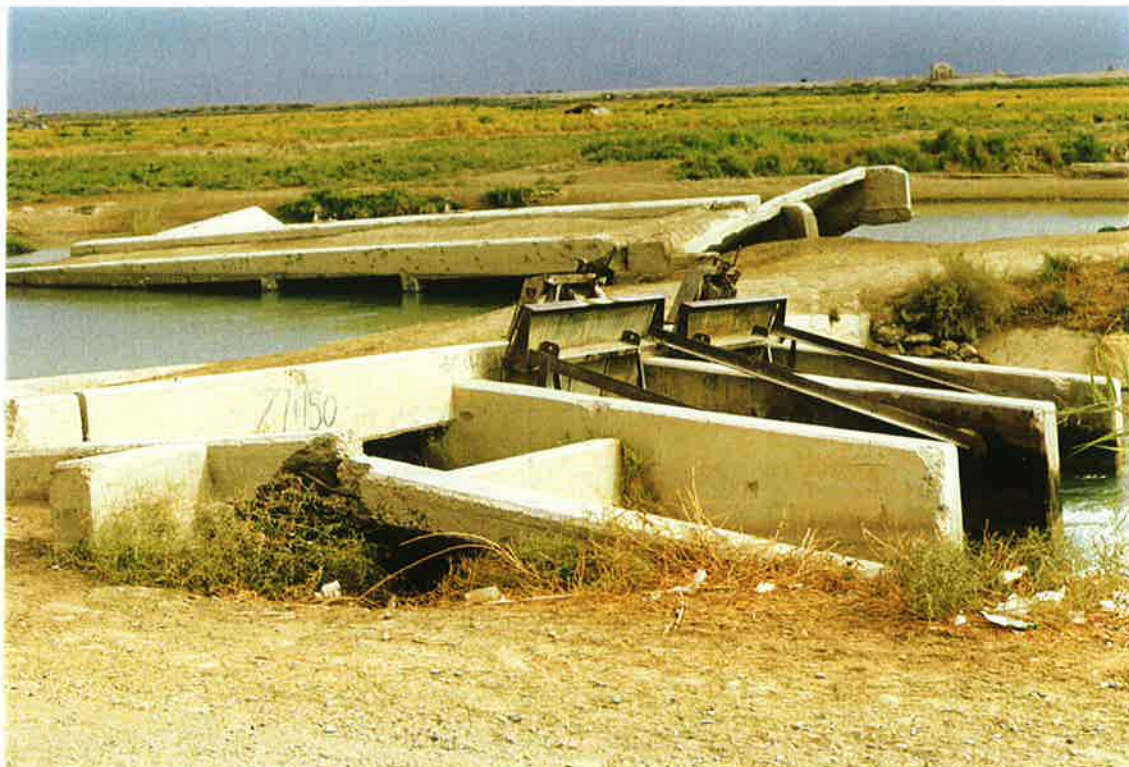
WASTEWAY 2 is badly damaged, the structures having been shifted by water pressure at some point when all gates were closed through bad management or malice (Photos No. 41 - 42). However, the control gates on the Shamalan Canal apparently still function.

41. Damaged diversion gates on Shamalan canal at Waste way # 2.
17 Oct 97

42. Damaged diversion gates on Shamalan canal at Waste way # 2.
17 Oct 97

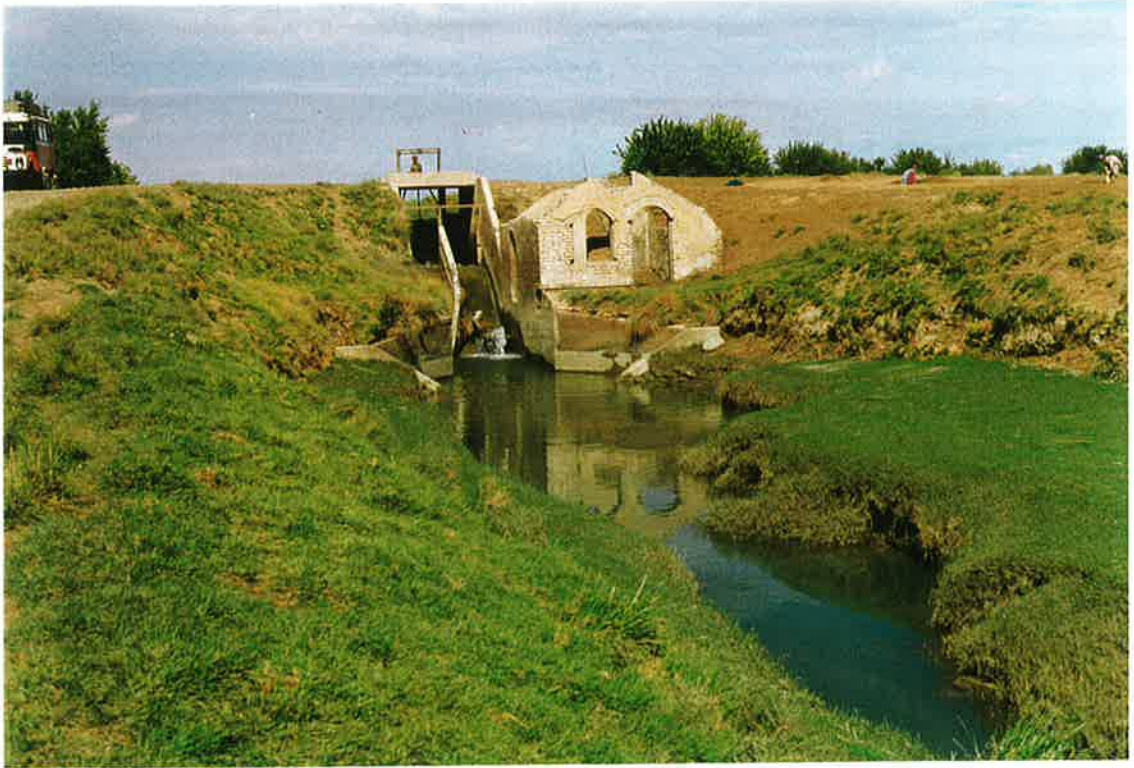
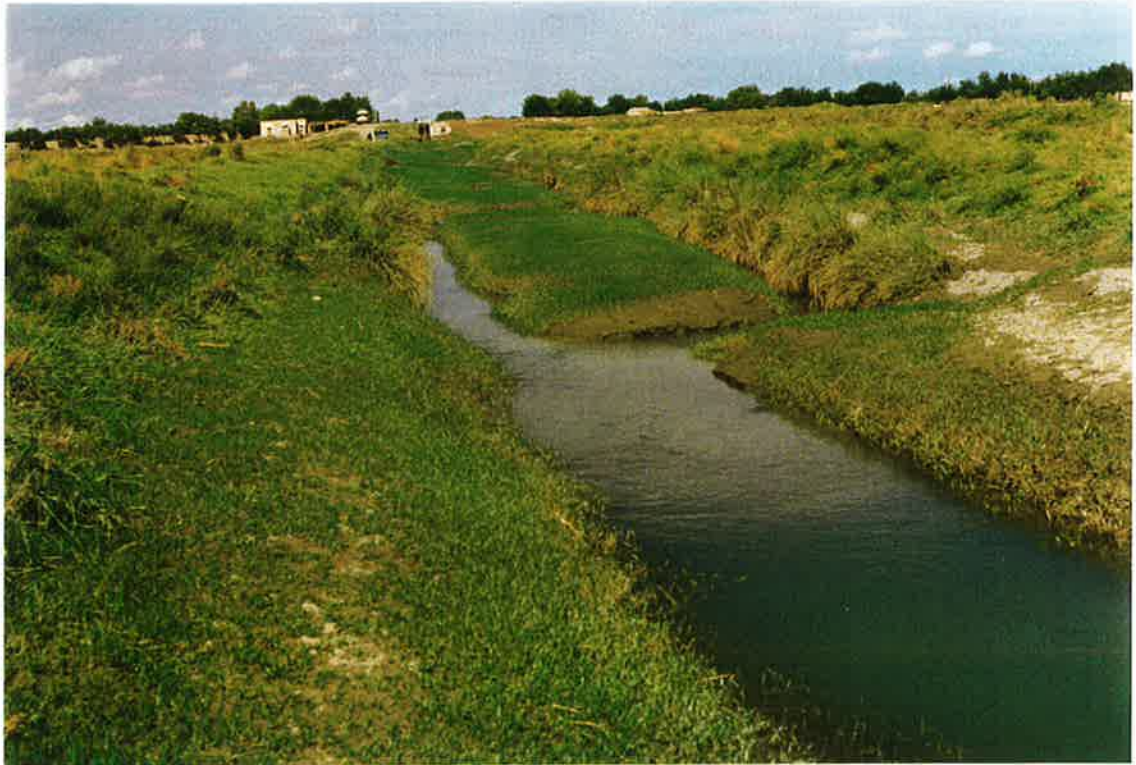
As can be noted in Photos No. 43 - 45, the southern reaches of the Shamalan Canal were very badly silted up but the crops appeared very healthy, mostly corn. The source of irrigation water for southern Shamalan was not clear. Marja wasteway is a possibility. In the entire region, wasteway and drainage water is widely used for irrigation.

43. Silted lower Shamslan canal at drop structure and old mill.
17 Oct 97

44. Silted lower Shamslan Canal, 17 Oct 97
